## Access Compliance Report Public Rights-of-Way (Curb Ramps)

Intersection ID: 23991 Main Street: MONTIBELLO\_DR Cross Street: RIVER\_RIDGE\_RD Location: SW

ADA ID: 6909F6529090 Ramp Type: PerpDiag Initial Pass/Fail: Fail Overall Compliance: No Severity Score: 12.5

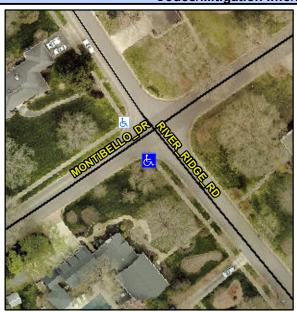
PROW/ADA:
Not Found, R304.2.2

Compliance Description Data Compliance Description Data No N/A Ramp Length (in) 33.0 Ramp Slope (%) 9.6 Yes Ramp XSlope (%) Yes Ramp Width (in) 48.0 0.6 N/A N/A Flare Type LT N/A Flare Type RT N/A N/A N/A N/A Flare Slope RT (%) N/A Flare Slope LT (%) N/A Flare Traversable LT? N/A N/A Flare Traversable RT? N/A N/A N/A N/A **DWS Provided?** N/A Landing Length (in) N/A Landing Width (in) N/A N/A **DWS Contrast?** N/A N/A N/A Landing Slope (%) N/A DWS Length (in) N/A N/A Landing X Slope (%) N/A N/A DWS Full Width? N/A N/A Landing Curb? (Y/N) N/A N/A DWS Offset (in) N/A N/A N/A Shared Landing? N/A Gutter Ponding? N/A N/A Gutter Slope (%) N/A N/A Gutter Lip Ht (in) N/A N/A Gutter X Slope (%) N/A N/A Painted X Walk1? No N/A Painted X Walk2? No X Walk 1 Direction To NE X Walk 2 Direction To NW N/A N/A X Walk 1 Width (in) X Walk 2 Width (in) N/A X Walk 1 Slope (%) 5.2 X Walk 2 Slope (%) 2.9 X Walk 1 X Slope (%) 2.6 X Walk 2 X Slope (%) 6.0 N/A N/A N/A Ramp inside XWalk2? Ramp inside XWalk1? N/A Road Slope (%) 1.5 N/A Clear Space? N/A N/A Road X Slope (%) 8.2 Clear Space to XWalk (in) N/A N/A N/A N/A Any Obstructions? Storm Grate/Utility Hazard? N/A **Obstruction Type** Storm Grate/Utility Type N/A N/A Yes Surface Condition? (G/P) Good

Remove & Replace Curb Ramp With
Two New Directional Ramps or
Equivalent.
