# Access Compliance Report

## Public Rights-of-Way

| Intersection ID: 45248 | Main Street: CALDWELL_RD | Cross Street: SUNBURST_LN | Location: | N |
| ADA ID: 6912A28DE6EB | Ramp Type: Perp | Initial Pass/Fail: Fail | Overall Compliance: No | Severity Score: 8.75 |

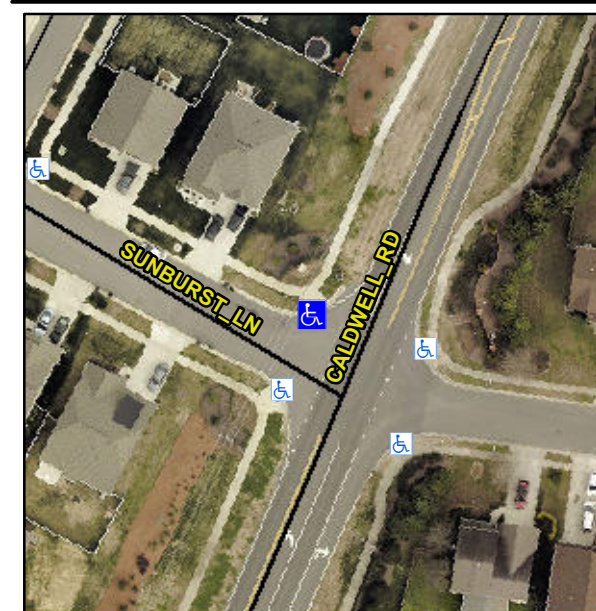
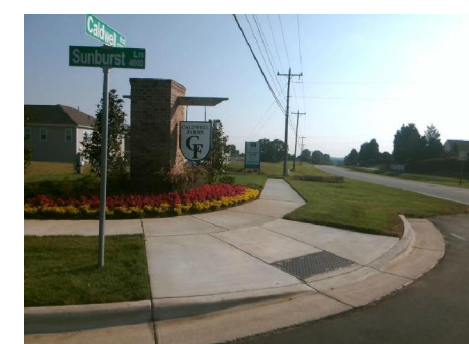
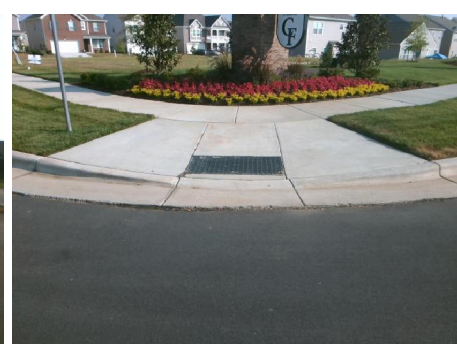
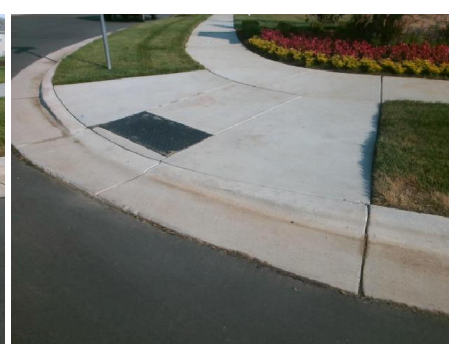
**Not Found, R304.5.1**

| Compliance | Description | Data | Compliance | Description | Data |
|---|---|---|---|---|---|
| N/A | Ramp Length (in) | 96.0 | Yes | Ramp Slope (%) | 6.7 |
| No | Ramp Width (in) | 46.5 | Yes | Ramp XSlope (%) | 0.6 |

**Remove & Replace Entire Ramp.**

Total Cost: \$ 1850.00
