Access Compliance Report Public Rights-of-Way (Curb Ramps)

Intersection ID: 16944Main Street:N_SHARON_AMITY_RDCross Street:MONTAGUE_STLocation:NWADA ID: 6913277451F1Ramp Type:PerpDiagInitial Pass/Fail:FailOverall Compliance:NoSeverity Score:33.75

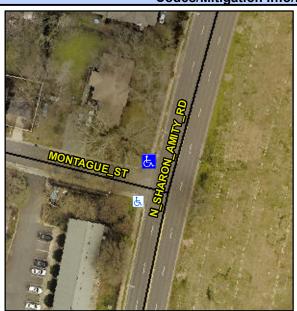
Field Measurements/Component Compliance						
	Comp	Compliance Description		Comp	liance Description	Data
	N/A	Ramp Length (in)	58.0	Yes	Ramp Slope (%)	5.9
	No	Ramp Width (in)	37.0	No	Ramp XSlope (%)	14.9
	N/A	Flare Type LT	N/A	N/A	Flare Type RT	N/A
	N/A	Flare Slope LT (%)	N/A	N/A	Flare Slope RT (%)	N/A
	N/A	Flare Traversable LT?	N/A	N/A	Flare Traversable RT?	N/A
	N/A	Landing Length (in)	N/A	N/A	DWS Provided?	N/A
	N/A	Landing Width (in)	N/A	N/A	DWS Contrast?	N/A
	N/A	Landing Slope (%)	N/A	N/A	DWS Length (in)	N/A
	N/A	Landing X Slope (%)	N/A	N/A	DWS Full Width?	N/A
	N/A	Landing Curb? (Y/N)	N/A	N/A	DWS Offset (in)	N/A
	N/A	Shared Landing?	N/A			
	N/A	Gutter Ponding?	N/A	N/A	Gutter Slope (%)	N/A
	N/A	Gutter Lip Ht (in)	N/A	N/A	Gutter X Slope (%)	N/A
	N/A	Painted X Walk1?	No	N/A	Painted X Walk2?	No
		X Walk 1 Direction	To S		X Walk 2 Direction	To E
	N/A	X Walk 1 Width (in)	N/A	N/A	X Walk 2 Width (in)	N/A
		X Walk 1 Slope (%)	0.2		X Walk 2 Slope (%)	3.5

X Walk 1 X Slope (%)	6.2		X Walk 2 X Slope (%)	0.1
	N/A	Ramp inside XWalk1?	N/A	N/A	Ramp inside XWalk2?	N/A
		Road Slope (%)	2.9	N/A	Clear Space?	N/A
		Road X Slope (%)	9.7	N/A	Clear Space to XWalk (in)	N/A
	N/A	Any Obstructions?	N/A	N/A	Storm Grate/Utility Hazard?	N/A
		Obstruction Type			Storm Grate/Utility Type	
		••	N/A			N/A
				Yes	Surface Condition? (G/P)	Good
24	A Part State		'	•	, ,

Remove & Replace Curb Ramp With Two New Directional Ramps or Equivalent.

R304.5.1, R304.5.3
