# Access Compliance Report

## Public Rights-of-Way

### (Curb Ramps)

Intersection ID: 21396	Main Street: W_ARROWOOD_RD	Cross Street: FOREST_PINE_DR	Location: SW
ADA ID: 697C1B267C77	Ramp Type: Combination2Diag	Initial Pass/Fail: Fail	Overall Compliance: No
		Severity Score: 0

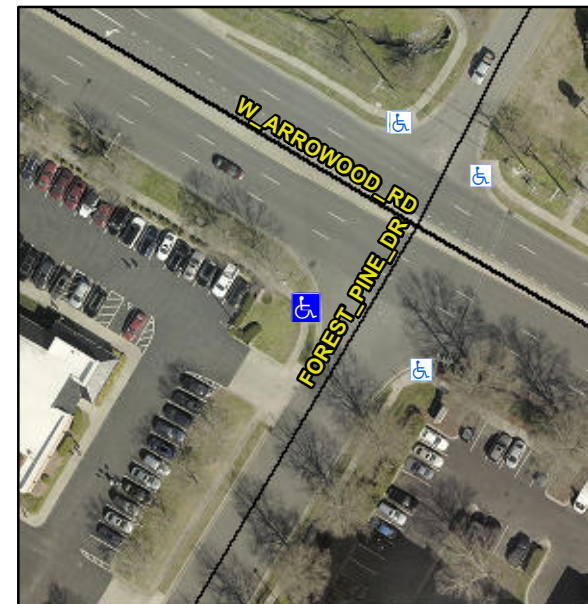
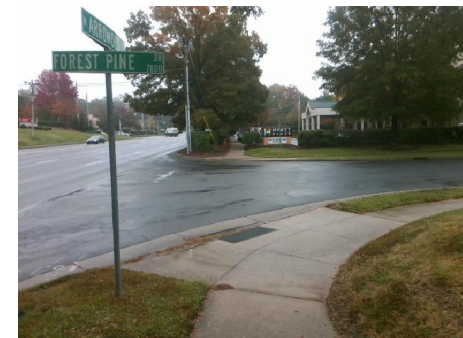
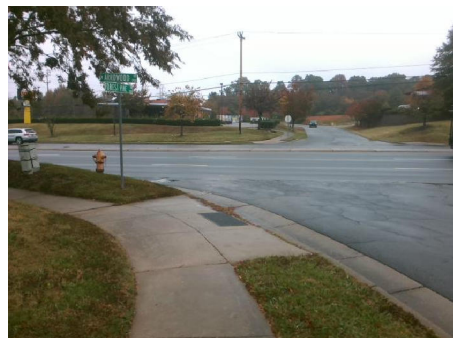
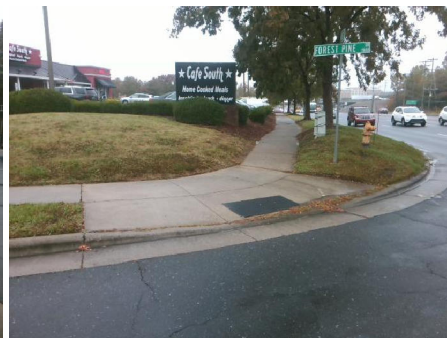
**MEDIAN ACROSS W ARROWOOD RD**

**R304.5.1, R304.5.3**

Compliance	Description	Data	Compliance	Description	Data
N/A	Ramp Length LT (in)	64.0	N/A	Ramp Length RT (in)	N/A
No	Ramp Width LT (in)	46.5	N/A	Ramp Width RT (in)	N/A
Yes	Ramp Slope LT (%)	5.2	N/A	Ramp Slope RT (%)	N/A
No	Ramp XSlope LT (%)	2.4	N/A	Ramp XSlope RT (%)	N/A
N/A	Ramp Length (in)	51.0	Yes	Ramp Slope (%)	6.9
Yes	Ramp Width (in)	61.0	No	Ramp XSlope (%)	2.4
N/A	Flare Type LT	N/A	N/A	Flare Type RT	N/A
N/A	Flare Slope LT (%)	N/A	N/A	Flare Slope RT (%)	N/A
N/A	Flare Traversable LT?	N/A	N/A	Flare Traversable RT?	N/A
N/A	Landing Length (in)	N/A	N/A	DWS Provided?	N/A
N/A	Landing Width (in)	N/A	N/A	DWS Contrast?	N/A
N/A	Landing Slope (%)	N/A	N/A	DWS Length (in)	N/A
N/A	Landing X Slope (%)	N/A	N/A	DWS Full Width?	N/A
N/A	Landing Curb? (Y/N)	N/A	N/A	DWS Offset (in)	N/A
N/A	Shared Landing?	N/A			
N/A	Gutter Ponding?	N/A	N/A	Gutter Slope (%)	N/A
N/A	Gutter Lip Ht (in)	N/A	N/A	Gutter X Slope (%)	N/A
N/A	Painted X Walk1?	No	N/A	Painted X Walk2?	No

X Walk 1 Direction	To SE		X Walk 2 Direction	To NE
	X Walk 1 Width (in)	N/A		X Walk 2 Width (in)	N/A
	X Walk 1 Slope (%)	1.4		X Walk 2 Slope (%)	2.3
	X Walk 1 X Slope (%)	2.3		X Walk 2 X Slope (%)	1.5
N/A	Ramp inside XWalk1?	N/A	N/A	Ramp inside XWalk2?	N/A
	Road Slope (%)	2.2		Clear Space?	N/A
	Road X Slope (%)	1.5	N/A	Clear Space to XWalk (in)	N/A
			N/A	Any Obstruction?	N/A
				Obstruction Type	N/A
			N/A	Storm Grate/Utility Hazard?	N/A
				Storm Grate/Utility Type	N/A
Yes	Surface Condition? (G/P)	Good			
	Curb Slope (%)	0.1

**Remove & Replace Curb Ramp With Two New Directional Ramps or Equivalent.**

Total Cost: \$ 3200.00
