# Access Compliance Report

## Public Rights-of-Way

### (Curb Ramps)

| Intersection ID: 47840 | Main Street: PECO_RD | Cross Street: CACTUS_VALLEY_RD | Location: NW |

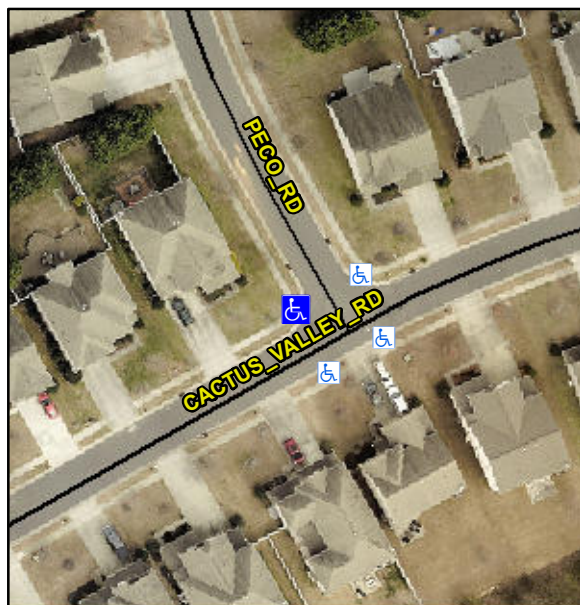
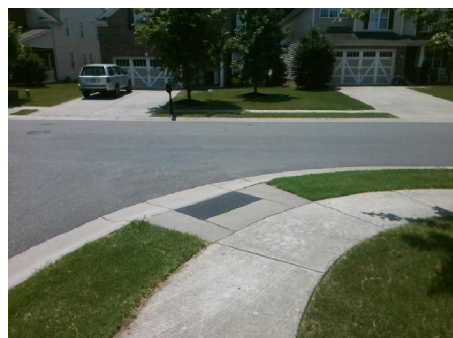
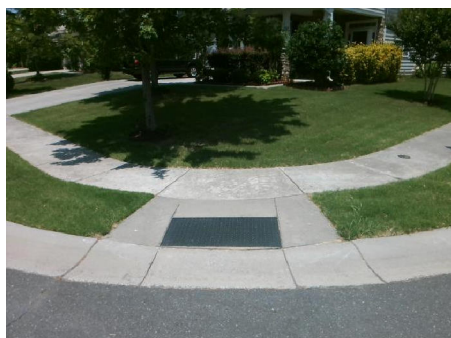
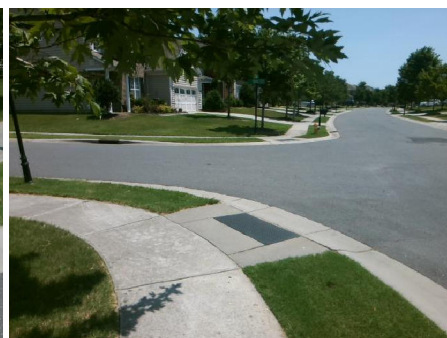
| ADA ID: 697C8833CF7F | Ramp Type: PerpDiag | Initial Pass/Fail: Fail | Overall Compliance: No |

**Not Found, R304.5.1, R304.5.3**

| Compliance | Description | Data | Compliance | Description | Data |
|---|---|---|---|---|---|
| N/A | Ramp Length (in) | 96.0 | Yes | Ramp Slope (%) | 6.3 |
| No | Ramp Width (in) | 47.0 | No | Ramp XSlope (%) | 4.4 |

**Remove & Replace Curb Ramp With Two New Directional Ramps or Equivalent.**

Total Cost: \$ 3200.00
