# Access Compliance Report

## Public Rights-of-Way

### (Curb Ramps)

Intersection ID: 42726	Main Street: CAMPION_CT	Cross Street: PICKEREL_LN	Location:	N
ADA ID: 697F7A8B3CC8	Ramp Type: PerpDiag	Initial Pass/Fail: Fail	Overall Compliance: No	Severity Score: 21.25
Codes/Mitigation Info/Possible Solution		Field Measurements/Component Compliance

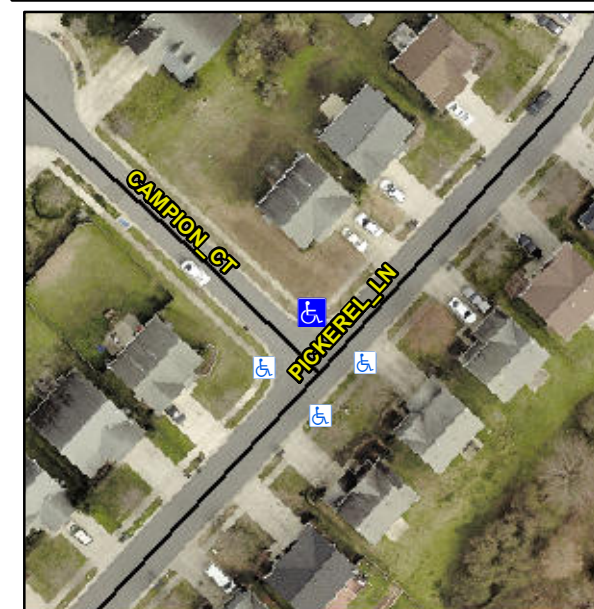
**Not Found, R304.5.1, R304.5.3**

Compliance	Description	Data	Compliance	Description	Data
N/A	Ramp Length (in)	47.0	Yes	Ramp Slope (%)	5.0
No	Ramp Width (in)	37.0	No	Ramp XSlope (%)	5.6
N/A	Flare Type LT	N/A	N/A	Flare Type RT	N/A
N/A	Flare Slope LT (%)	N/A	N/A	Flare Slope RT (%)	N/A
N/A	Flare Traversable LT?	N/A	N/A	Flare Traversable RT?	N/A
N/A	Landing Length (in)	N/A	N/A	DWS Provided?	N/A
N/A	Landing Width (in)	N/A	N/A	DWS Contrast?	N/A
N/A	Landing Slope (%)	N/A	N/A	DWS Length (in)	N/A
N/A	Landing X Slope (%)	N/A	N/A	DWS Full Width?	N/A
N/A	Landing Curb? (Y/N)	N/A	N/A	DWS Offset (in)	N/A
N/A	Shared Landing?	N/A			
N/A	Gutter Ponding?	N/A	N/A	Gutter Slope (%)	N/A
N/A	Gutter Lip Ht (in)	N/A	N/A	Gutter X Slope (%)	N/A
N/A	Painted X Walk1?	No	N/A	Painted X Walk2?	No
	X Walk 1 Direction	To SW		X Walk 2 Direction	To SE
N/A	X Walk 1 Width (in)	N/A	N/A	X Walk 2 Width (in)	N/A
	X Walk 1 Slope (%)	8.2		X Walk 2 Slope (%)	5.4
	X Walk 1 X Slope (%)	1.5		X Walk 2 X Slope (%)	0.1

N/A	Ramp inside XWalk1?	N/A	N/A	Ramp inside XWalk2?	N/A
	Road Slope (%)	5.0	N/A	Clear Space?	N/A
	Road X Slope (%)	3.2	N/A	Clear Space to XWalk (in)	N/A
N/A	Any Obstructions?	N/A	N/A	Storm Grate/Utility Hazard?	N/A
	Obstruction Type			Storm Grate/Utility Type	
		N/A			N/A
			Yes	Surface Condition? (G/P)	Good

**Remove & Replace Curb Ramp With Two New Directional Ramps or Equivalent.**

Total Cost: \$ 3200.00
