Intersection ID: 50531 Main Street: KENDALL DR **Cross Street: SAMLEN LN** Location: NE ADA ID: 69902239DB4B Ramp Type: Perp Initial Pass/Fail: Fail **Overall Compliance: No Severity Score:** 25

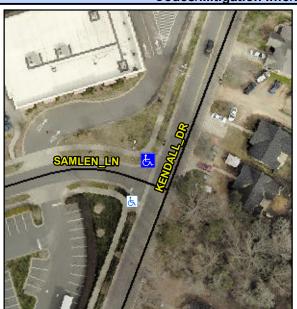
N/A	Ramp Length (in)	96.0	Yes	Ramp Slope (%)
Yes	Ramp Width (in)	56.0	No	Ramp XSlope (%)
N/A	Flare Type LT	N/A	N/A	Flare Type RT
N/A	Flare Slope LT (%)	N/A	N/A	Flare Slope RT (%)
N/A	Flare Traversable LT?	N/A	N/A	Flare Traversable RT?
N/A	Landing Length (in)	N/A	N/A	DWS Provided?
N/A	Landing Width (in)	N/A	N/A	DWS Contrast?
N/A	Landing Slope (%)	N/A	N/A	DWS Length (in)
N/A	Landing X Slope (%)	N/A	N/A	DWS Full Width?
N/A	Landing Curb? (Y/N)	N/A	N/A	DWS Offset (in)
N/A	Shared Landing?	N/A		
N/A	Gutter Ponding?	N/A	N/A	Gutter Slope (%)
N/A	Gutter Lip Ht (in)	N/A	N/A	Gutter X Slope (%)
N/A	Painted X Walk1?	No	N/A	Painted X Walk2?
	X Walk 1 Direction	To SW		X Walk 2 Direction
N/A	X Walk 1 Width (in)	N/A	N/A	X Walk 2 Width (in)
	X Walk 1 Slope (%)	3.6		X Walk 2 Slope (%)
	X Walk 1 X Slope (%)	7.5		X Walk 2 X Slope (%)
N/A	Ramp inside XWalk1?	N/A	N/A	Ramp inside XWalk2?
	Road Slope (%)	N/A	N/A	Clear Space?
	Road X Slope (%)	N/A	N/A	Clear Space to XWalk (in)

Possible Solutions:	
Remove & Replace Entire Ramp.	
Surveyor Notes:	
N/A	
PROW/ADA:	
R304.5.3
