# Access Compliance Report

## Public Rights-of-Way

### (Curb Ramps)

Intersection ID: 49309	Main Street: NATIONS_FORD_RD	Cross Street: PANGLE_DR	Location: E
ADA ID: 6992FDB5ED3C	Ramp Type: PerpDiag	Initial Pass/Fail: Fail	Overall Compliance: No
			Severity Score: 13.75

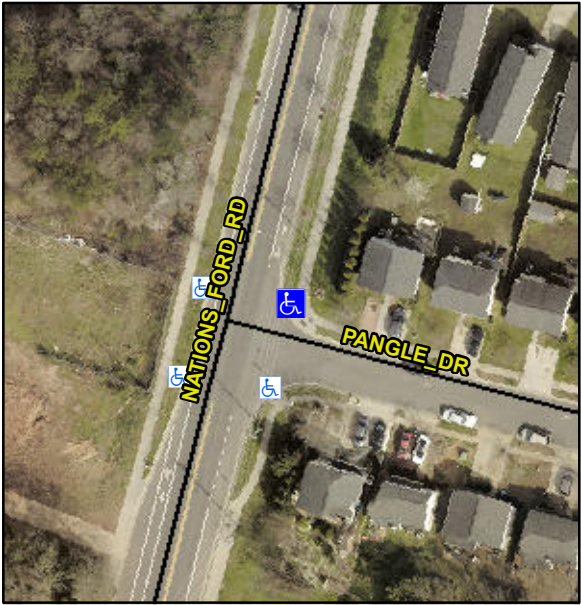
Possible Solutions:		<b>Compliance</b>	<b>Description</b>	<b>Data</b>
	<b>Remove &amp; Replace Curb Ramp With Two New Directional Ramps or Equivalent.</b>		<b>No</b>	Ramp Length (in)	<b>52.0</b>
			<b>Yes</b>	Ramp Width (in)	<b>48.0</b>
			<b>N/A</b>	Flare Type LT	<b>N/A</b>
			<b>N/A</b>	Flare Slope LT (%)	<b>N/A</b>
			<b>N/A</b>	Flare Traversable LT?	<b>N/A</b>
			<b>N/A</b>	Landing Length (in)	<b>N/A</b>
			<b>N/A</b>	Landing Width (in)	<b>N/A</b>
			<b>N/A</b>	Landing Slope (%)	<b>N/A</b>
			<b>N/A</b>	Landing X Slope (%)	<b>N/A</b>
<p>Surveyor Notes:</p> <p><b>N/A</b></p> <p>PROW/ADA:</p> <p><b>Not Found, R304.2.2, R304.5.3</b></p>			<b>N/A</b>	Flare Type RT	<b>N/A</b>
			<b>N/A</b>	Flare Slope RT (%)	<b>N/A</b>
			<b>N/A</b>	Flare Traversable RT?	<b>N/A</b>
			<b>N/A</b>	DWS Provided?	<b>N/A</b>
			<b>N/A</b>	DWS Contrast?	<b>N/A</b>

<b>N/A</b>	DWS Length (in)	<b>N/A</b>
			<b>N/A</b>	DWS Full Width?	<b>N/A</b>
			<b>N/A</b>	DWS Offset (in)	<b>N/A</b>
			<b>N/A</b>	Gutter Ponding?	<b>N/A</b>
			<b>N/A</b>	Gutter Lip Ht (in)	<b>N/A</b>
			<b>No</b>	Painted X Walk1?	<b>No</b>
				X Walk 1 Direction	<b>To NW</b>
			<b>N/A</b>	X Walk 1 Width (in)	<b>N/A</b>
			<b>5.2</b>	X Walk 1 Slope (%)	<b>1.6</b>
			<b>0.6</b>	X Walk 1 X Slope (%)	<b>5.9</b>
			<b>N/A</b>	Ramp inside XWalk1?	<b>N/A</b>
			<b>5.8</b>	Road Slope (%)	<b>N/A</b>
			<b>3.9</b>	Road X Slope (%)	<b>N/A</b>
			<b>N/A</b>	Any Obstructions?	<b>N/A</b>
				Obstruction Type	
Total Cost: \$ 3200.00			<b>N/A</b>	Storm Grate/Utility Hazard?	<b>N/A</b>
			<b>N/A</b>	Storm Grate/Utility Type	<b>N/A</b>
			<b>Yes</b>	Surface Condition? (G/P)	<b>Good</b>
