Access Compliance Report Public Rights-of-Way (Curb Ramps)

Intersection ID: 13225 Main Street: MOREHEAD SQUARE DR Cross Street: E CARSON BV Location: NE

ADA ID: 6997EC4DCE03 Ramp Type: Perp Initial Pass/Fail: Fail Overall Compliance: No Severity Score: 12.5

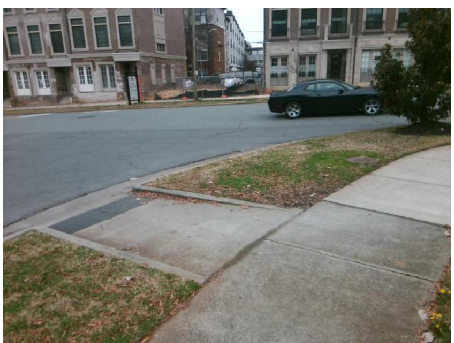
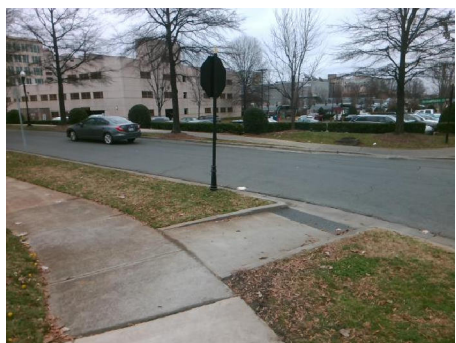
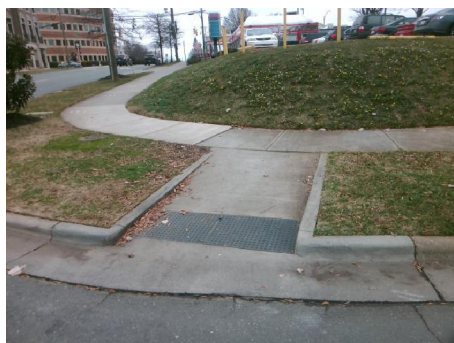
PROW/ADA:
Not Found, R304.2.2

Compliance	Description	Data	Compliance	Description	Data
N/A	Ramp Length (in)	130.0	No	Ramp Slope (%)	9.2
Yes	Ramp Width (in)	72.0	Yes	Ramp XSlope (%)	0.5
N/A	Flare Type LT	N/A	N/A	Flare Type RT	N/A
N/A	Flare Slope LT (%)	N/A	N/A	Flare Slope RT (%)	N/A
N/A	Flare Traversable LT?	N/A	N/A	Flare Traversable RT?	N/A
N/A	Landing Length (in)	N/A	N/A	DWS Provided?	N/A
N/A	Landing Width (in)	N/A	N/A	DWS Contrast?	N/A
N/A	Landing Slope (%)	N/A	N/A	DWS Length (in)	N/A
N/A	Landing X Slope (%)	N/A	N/A	DWS Full Width?	N/A
N/A	Landing Curb? (Y/N)	N/A	N/A	DWS Offset (in)	N/A
N/A	Shared Landing?	N/A			
N/A	Gutter Ponding?	N/A	N/A	Gutter Slope (%)	N/A
N/A	Gutter Lip Ht (in)	N/A	N/A	Gutter X Slope (%)	N/A
N/A	Painted X Walk1?	No	N/A	Painted X Walk2?	N/A
	X Walk 1 Direction	To SE		X Walk 2 Direction	N/A
N/A	X Walk 1 Width (in)	N/A	N/A	X Walk 2 Width (in)	N/A
	X Walk 1 Slope (%)	2.5		X Walk 2 Slope (%)	N/A
	X Walk 1 X Slope (%)	1.0		X Walk 2 X Slope (%)	N/A

N/A	Ramp inside XWalk1?	N/A	N/A	Ramp inside XWalk2?	N/A
	Road Slope (%)	N/A	N/A	Clear Space?	N/A
	Road X Slope (%)	N/A	N/A	Clear Space to XWalk (in)	N/A
N/A	Any Obstructions?	N/A	N/A	Storm Grate/Utility Hazard?	N/A
	Obstruction Type			Storm Grate/Utility Type	
			N/A		N/A
			Yes	Surface Condition? (G/P)	Good

Possible Solutions:
Remove & Replace Entire Ramp.

Total Cost: \$ **1850.00**
