Access Compliance Report

Public Rights-of-Way

(Curb Ramps)

| Intersection ID: 2891 | Main Street: BEAROAK_LN | Cross Street: RIDGEFIELD_DR | Location: | N |

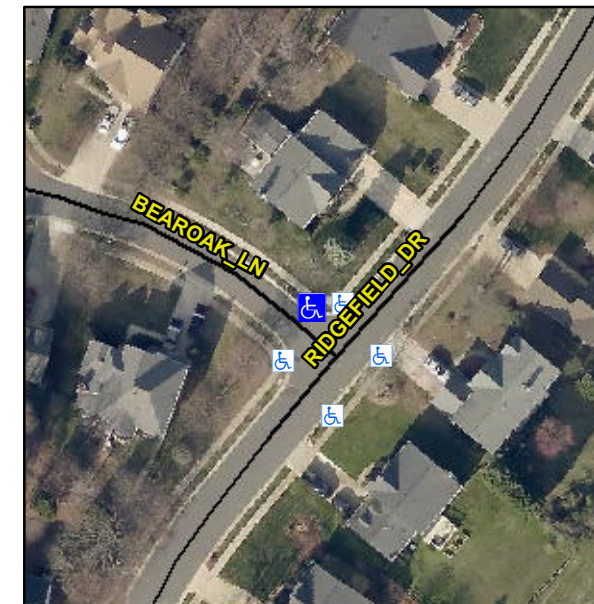
| ADA ID: 69BC9DAFF9D0 | Ramp Type: Perp | Initial Pass/Fail: Fail | Overall Compliance: No | Severity Score: 22.5 |

R304.5.1, R304.2.2, R304.5.3

| Compliance | Description | Data | Compliance | Description | Data |
|---|---|---|---|---|---|
| N/A | Ramp Length (in) | 49.0 | No | Ramp Slope (%) | 10.5 |
| No | Ramp Width (in) | 36.0 | No | Ramp XSlope (%) | 4.1 |

Possible Solutions:

Remove & Replace Entire Ramp.
