Access Compliance Report

Public Rights-of-Way

(Curb Ramps)

Intersection ID: 10022610	Main Street: CARMEL_RD	Cross Street: N/A	Location: SW
ADA ID: 69C269C3ACCD	Ramp Type: PerpDiag	Initial Pass/Fail: Fail	Overall Compliance: No
Severity Score: 12.5			
Codes/Mitigation Info/Possible Solution		Field Measurements/Component Compliance

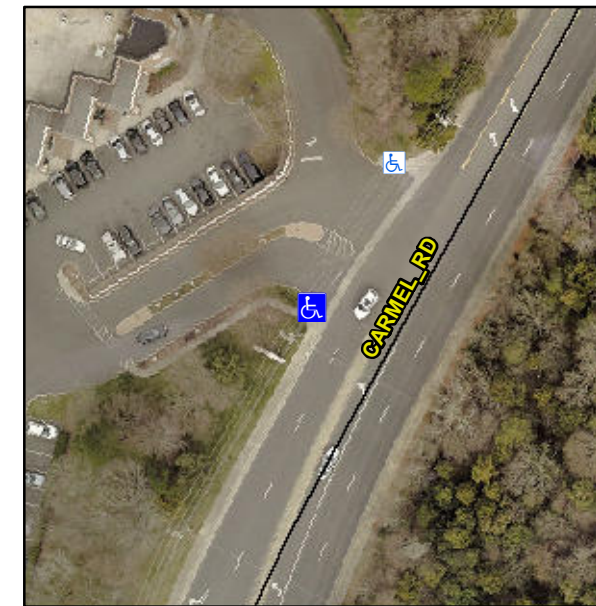
R304.5.3

Compliance	Description	Data	Compliance	Description	Data
N/A	Ramp Length (in)	60.0	Yes	Ramp Slope (%)	5.8
Yes	Ramp Width (in)	48.0	No	Ramp XSlope (%)	6.9
N/A	Flare Type LT	N/A	N/A	Flare Type RT	N/A
N/A	Flare Slope LT (%)	N/A	N/A	Flare Slope RT (%)	N/A
N/A	Flare Traversable LT?	N/A	N/A	Flare Traversable RT?	N/A
N/A	Landing Length (in)	N/A	N/A	DWS Provided?	N/A
N/A	Landing Width (in)	N/A	N/A	DWS Contrast?	N/A
N/A	Landing Slope (%)	N/A	N/A	DWS Length (in)	N/A
N/A	Landing X Slope (%)	N/A	N/A	DWS Full Width?	N/A
N/A	Landing Curb? (Y/N)	N/A	N/A	DWS Offset (in)	N/A
N/A	Shared Landing?	N/A			
N/A	Gutter Ponding?	N/A	N/A	Gutter Slope (%)	N/A
N/A	Gutter Lip Ht (in)	N/A	N/A	Gutter X Slope (%)	N/A
N/A	Painted X Walk1?	No	N/A	Painted X Walk2?	No
	X Walk 1 Direction	To E		X Walk 2 Direction	To NE
N/A	X Walk 1 Width (in)	N/A	N/A	X Walk 2 Width (in)	N/A
	X Walk 1 Slope (%)	4.7		X Walk 2 Slope (%)	1.1
	X Walk 1 X Slope (%)	4.0		X Walk 2 X Slope (%)	5.9

N/A	Ramp inside XWalk1?	N/A	N/A	Ramp inside XWalk2?	N/A
	Road Slope (%)	4.8	N/A	Clear Space?	N/A
	Road X Slope (%)	5.7	N/A	Clear Space to XWalk (in)	N/A
N/A	Any Obstructions?	N/A	N/A	Storm Grate/Utility Hazard?	N/A
	Obstruction Type			Storm Grate/Utility Type	
		N/A			N/A
		Yes		Surface Condition? (G/P)	Good

Remove & Replace Curb Ramp With Two New Directional Ramps or Equivalent.

Total Cost: \$ 3200.00
