Access Compliance Report

Public Rights-of-Way

(Curb Ramps)

Intersection ID: 10034489	Main Street: PINEBURR_RD	Cross Street: N/A	Location: SE
ADA ID: 69C82D816952	Ramp Type: BlendTrans2	Initial Pass/Fail: Fail	Overall Compliance: No
Severity Score: 12.5			
Codes/Mitigation Info/Possible Solution		Field Measurements/Component Compliance

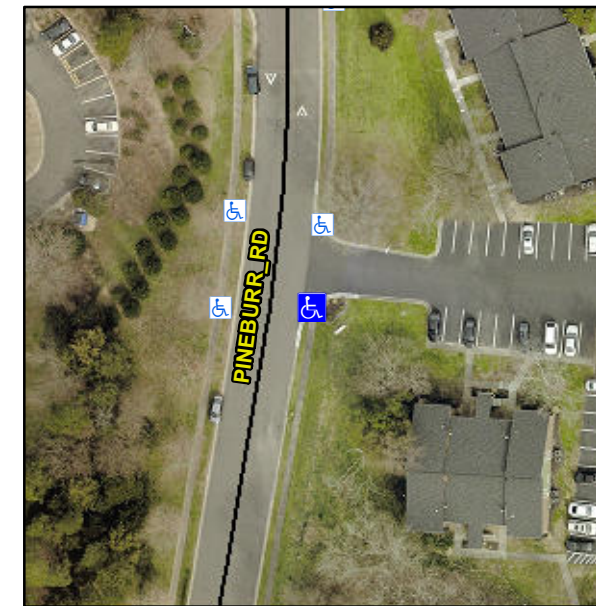
Not Found, R304.5.3

Compliance	Description	Data	Compliance	Description	Data
N/A	Ramp Length (in)	39.0	Yes	BlendTrans Slope (%)	2.4
Yes	Ramp Width (in)	48.0	No	BlendTrans XSlope (%)	5.1
N/A	Flare Type LT	N/A	N/A	Flare Type RT	N/A
N/A	Flare Slope LT (%)	N/A	N/A	Flare Slope RT (%)	N/A
N/A	Flare Traversable LT?	N/A	N/A	Flare Traversable RT?	N/A
N/A	Landing Length (in)	N/A	N/A	DWS Provided?	N/A
N/A	Landing Width (in)	N/A	N/A	DWS Contrast?	N/A
N/A	Landing Slope (%)	N/A	N/A	DWS Length (in)	N/A
N/A	Landing X Slope (%)	N/A	N/A	DWS Full Width?	N/A
N/A	Landing Curb? (Y/N)	N/A	N/A	DWS Offset (in)	N/A
N/A	Shared Landing?	N/A			
N/A	Gutter Ponding?	N/A	N/A	Gutter Slope (%)	N/A
N/A	Gutter Lip Ht (in)	N/A	N/A	Gutter X Slope (%)	N/A
N/A	Painted X Walk1?	No	N/A	Painted X Walk2?	No
	X Walk 1 Direction	To N		X Walk 2 Direction	To W
	X Walk 1 Width (in)	N/A		X Walk 2 Width (in)	N/A
	X Walk 1 Slope (%)	6.9		X Walk 2 Slope (%)	4.5
	X Walk 1 X Slope (%)	0.1		X Walk 2 X Slope (%)	6.3

N/A	Ramp inside XWalk1?	N/A	N/A	Ramp inside XWalk2?	N/A
	Road Slope (%)	4.5		Clear Space?	N/A
	Road X Slope (%)	7.6	N/A	Clear Space to XWalk (in)	N/A
N/A	Any Obstructions?	N/A	N/A	Storm Grate/Utility Hazard?	N/A
	Obstruction Type			Storm Grate/Utility Type	
		N/A			N/A
			Yes	Surface Condition? (G/P)	Good
			No	Curb Slope (%)	11.4

Remove & Replace Curb Ramp With Two New Directional Ramps or Equivalent.

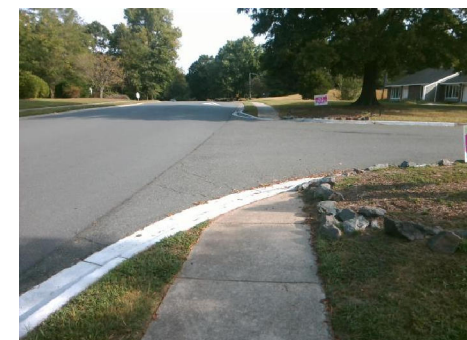
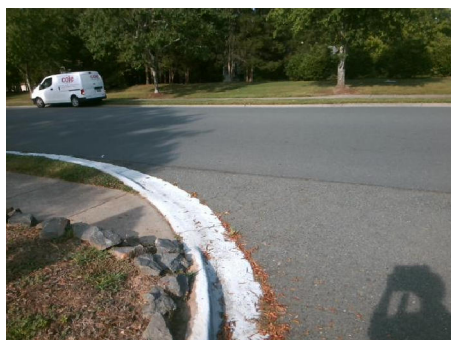
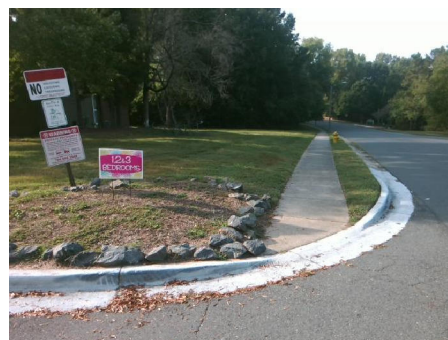
Street 1 Name PRIVATE DRIVE
 Stop Condition-Street 1 StopSign
 Street 2 Name PINEBURR RD
 Stop Condition-Street 2 None
