# Access Compliance Report

## Public Rights-of-Way

### (Curb Ramps)

Intersection ID: 18109	Main Street: DREXEL_PL	Cross Street: PARK_RD	Location: SW
ADA ID: 69CEF60FFC83	Ramp Type: PerpDiag	Initial Pass/Fail: Fail	Overall Compliance: No
Codes/Mitigation Info/Possible Solution		Field Measurements/Component Compliance	
Severity Score: 21.25

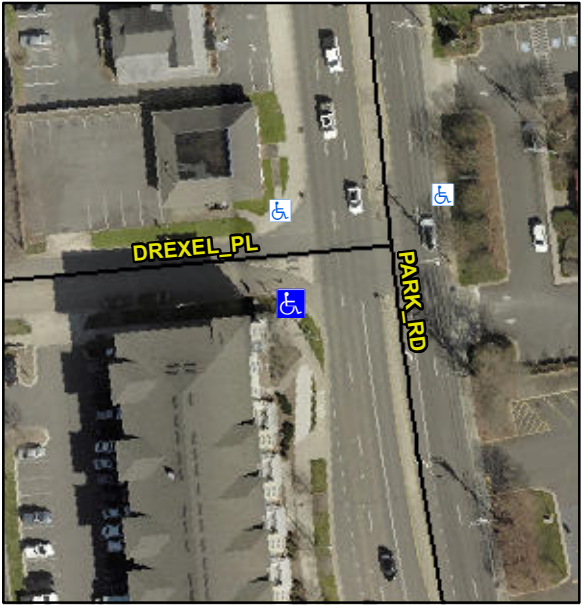
X Walk 1 Direction	To E		X Walk 2 Direction	To N
		N/A	X Walk 1 Width (in)	N/A	N/A	X Walk 2 Width (in)	N/A
			X Walk 1 Slope (%)	1.2		X Walk 2 Slope (%)	1.6
			X Walk 1 X Slope (%)	2.1		X Walk 2 X Slope (%)	2.6
		N/A	Ramp inside XWalk1?	N/A	N/A	Ramp inside XWalk2?	N/A
<p>Street 1 Name</p> <p>Stop Condition-Street 2</p> <p>Street 2 Name</p> <p>Stop Condition-Street 1</p>			Road Slope (%)	3.8	N/A	Clear Space?	N/A
			Road X Slope (%)	1.6	N/A	Clear Space to XWalk (in)	N/A
		N/A	Any Obstructions?	N/A	N/A	Storm Grate/Utility Hazard?	N/A
			Obstruction Type			Storm Grate/Utility Type	
					N/A		N/A
					Yes	Surface Condition? (G/P)	Good
Total Cost:		\$	3200.00

Possible Solutions:	Compliance	Description	Data	Compliance	Description	Data
	Remove & Replace Curb Ramp With Two New Directional Ramps or Equivalent.	N/A	Ramp Length (in)	96.0	No	Ramp Slope (%)	10.0
		No	Ramp Width (in)	47.0	Yes	Ramp XSlope (%)	1.8
		N/A	Flare Type LT	N/A	N/A	Flare Type RT	N/A
		N/A	Flare Slope LT (%)	N/A	N/A	Flare Slope RT (%)	N/A
		N/A	Flare Traversable LT?	N/A	N/A	Flare Traversable RT?	N/A
		N/A	Landing Length (in)	N/A	N/A	DWS Provided?	N/A
		N/A	Landing Width (in)	N/A	N/A	DWS Contrast?	N/A
		N/A	Landing Slope (%)	N/A	N/A	DWS Length (in)	N/A
		N/A	Landing X Slope (%)	N/A	N/A	DWS Full Width?	N/A
<p>Surveyor Notes:</p> <p>N/A</p> <p>PROW/ADA:</p> <p>Not Found, R304.5.1, R304.2.2</p>		N/A	Landing Curb? (Y/N)	N/A	N/A	DWS Offset (in)	N/A
		N/A	Shared Landing?	N/A			
		N/A	Gutter Ponding?	N/A	N/A	Gutter Slope (%)	N/A
		N/A	Gutter Lip Ht (in)	N/A	N/A	Gutter X Slope (%)	N/A
		N/A	Painted X Walk1?	No	N/A	Painted X Walk2?	No
