# Access Compliance Report

## Public Rights-of-Way

### (Curb Ramps)

| Intersection ID: 53017 | Main Street: STEEL_HOUSE_BV | Cross Street: CHARTRES_LN | Location: NW |

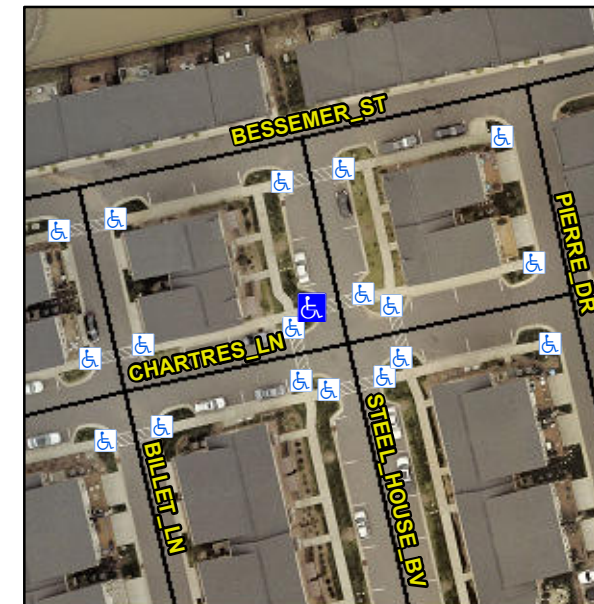
| ADA ID: 69D5B7296104 | Ramp Type: Directional1 | Initial Pass/Fail: Pass | Overall Compliance: No |
| | | Severity Score: 2.5 | |

**R305.1.4, R304.5.3**

| Compliance | Description | Data | Compliance | Description | Data |
|---|---|---|---|---|---|
| Yes | Landing X Slope (%) | 1.8 | No | DWS Full Width? | No |
| Yes | Gutter Lip Ht (in) | 0.0 | No | Gutter X Slope (%) | 2.1 |

**Remove & Replace Detectable Warning System. Remove & Replace Gutter.**

Total Cost: \$ 1550.00

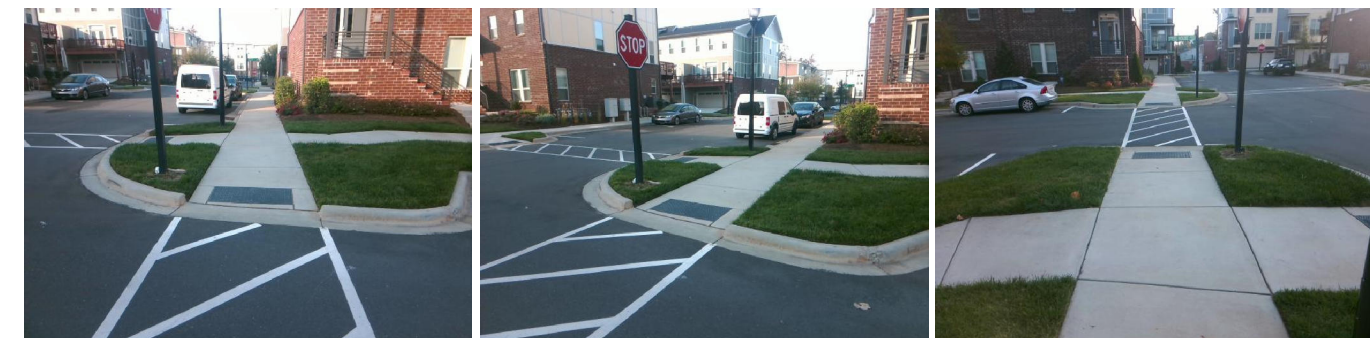
| Compliance | Description | Data | Compliance | Description | Data |
|---|---|---|---|---|---|
| | X Walk 1 X Slope (%) | 3.0 | Yes | Storm Grate/Utility Hazard? | No |
| | | | N/A | Curb Slope (%) | 5.7 |
