Access Compliance Report

Public Rights-of-Way

(Curb Ramps)

| Intersection ID: 15178 | Main Street: DILWORTH_RD_EAST | Cross Street: IDEAL_WY | Location: SW |

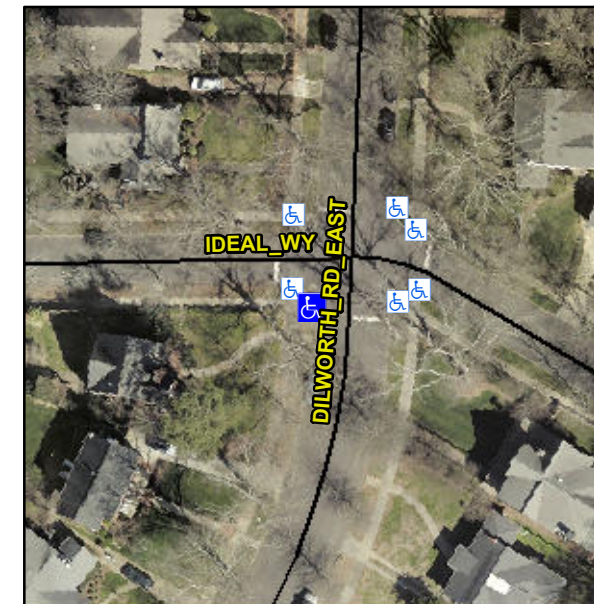
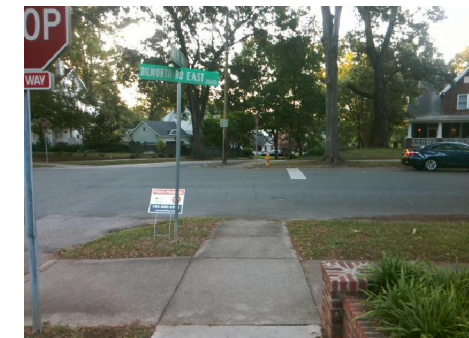
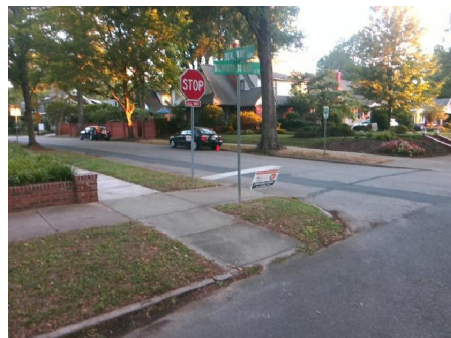
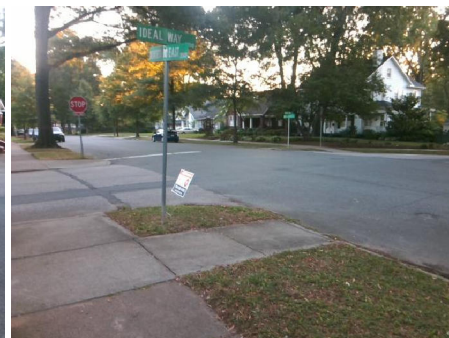
| ADA ID: 69DF52FC60FD | Ramp Type: Perp | Initial Pass/Fail: Fail | Overall Compliance: No |
| | | | Severity Score: 1.25 |

| Compliance | Description | Data | Compliance | Description | Data |
|---|---|---|---|---|---|
| N/A | Ramp Length (in) | 102.0 | Yes | Ramp Slope (%) | 6.0 |
| Yes | Ramp Width (in) | 60.0 | No | Ramp XSlope (%) | 2.1 |

Possible Solutions:

Remove & Replace Entire Ramp.

R304.5.3

\$ 1850.00
