Access Compliance Report

Public Rights-of-Way

(Curb Ramps)

Intersection ID: 8668	Main Street: BROWNSTONE_ST	Cross Street: HATERAS_AV	Location: SW
ADA ID: 69E9DE6EAF2A	Ramp Type: Perp	Initial Pass/Fail: Fail	Overall Compliance: No
		Severity Score: 25

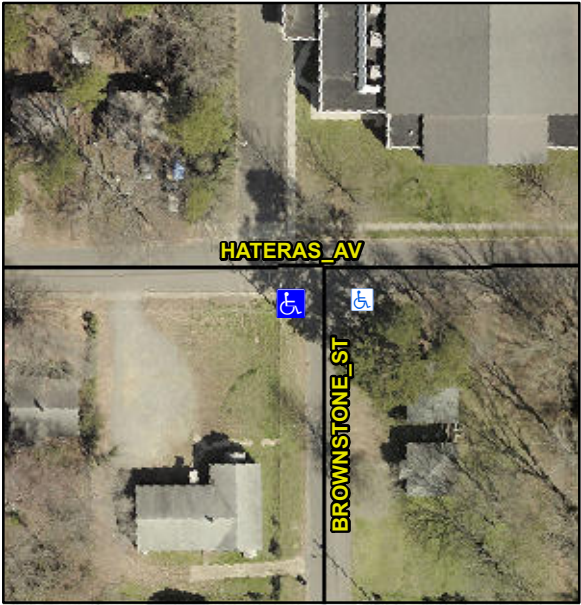
Possible Solutions:		Compliance	Description	Data
	Remove & Replace Entire Ramp.		No	Ramp Length (in)	40.0
			Yes	Ramp Width (in)	60.0
			N/A	Flare Type LT	N/A
			N/A	Flare Slope LT (%)	N/A
			N/A	Flare Traversable LT?	N/A
			N/A	Landing Length (in)	N/A
			N/A	Landing Width (in)	N/A
			N/A	Landing Slope (%)	N/A
			N/A	Landing X Slope (%)	N/A
<p>Surveyor Notes:</p> <p>N/A</p> <p>PROW/ADA:</p> <p>Not Found, R304.2.2</p>			N/A	Flare Type RT	N/A
			N/A	Flare Slope RT (%)	N/A
			N/A	Flare Traversable RT?	N/A
			N/A	DWS Provided?	N/A
			N/A	DWS Contrast?	N/A
			N/A	DWS Length (in)	N/A
			N/A	DWS Full Width?	N/A
			N/A	DWS Offset (in)	N/A
			N/A	Gutter Ponding?	N/A
			N/A	Gutter Lip Ht (in)	N/A
			No	Painted X Walk1?	N/A
				X Walk 1 Direction	To E
			N/A	X Walk 1 Width (in)	N/A
				X Walk 1 Slope (%)	2.4
				X Walk 1 X Slope (%)	2.9
			N/A	Ramp inside XWalk1?	N/A

N/A	Road Slope (%)	N/A
			N/A	Road X Slope (%)	N/A
			N/A	Any Obstructions?	N/A
				Obstruction Type	
Total Cost: \$ 1850.00			N/A	Storm Grate/Utility Hazard?	N/A
				Storm Grate/Utility Type	
			N/A		N/A
			Yes	Surface Condition? (G/P)	Good
