# Access Compliance Report

## Public Rights-of-Way

### (Curb Ramps)

Intersection ID: 32032	Main Street: COLONY_RD	Cross Street: WAKEHURST_RD	Location: SE
ADA ID: 69EC9EFD576A	Ramp Type: PerpDiag	Initial Pass/Fail: Fail	Overall Compliance: No
Severity Score: 22.5			
Codes/Mitigation Info/Possible Solution		Field Measurements/Component Compliance

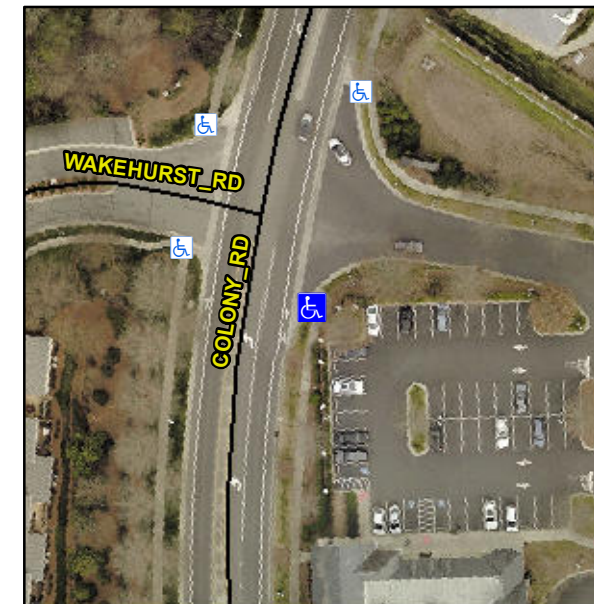
**Not Found, R304.5.1, R304.2.2, R304.5.3**

Compliance	Description	Data	Compliance	Description	Data
N/A	Ramp Length (in)	53.0	No	Ramp Slope (%)	10.5
No	Ramp Width (in)	44.0	No	Ramp XSlope (%)	4.8
N/A	Flare Type LT	N/A	N/A	Flare Type RT	N/A
N/A	Flare Slope LT (%)	N/A	N/A	Flare Slope RT (%)	N/A
N/A	Flare Traversable LT?	N/A	N/A	Flare Traversable RT?	N/A
N/A	Landing Length (in)	N/A	N/A	DWS Provided?	N/A
N/A	Landing Width (in)	N/A	N/A	DWS Contrast?	N/A
N/A	Landing Slope (%)	N/A	N/A	DWS Length (in)	N/A
N/A	Landing X Slope (%)	N/A	N/A	DWS Full Width?	N/A
N/A	Landing Curb? (Y/N)	N/A	N/A	DWS Offset (in)	N/A
N/A	Shared Landing?	N/A			
N/A	Gutter Ponding?	N/A	N/A	Gutter Slope (%)	N/A
N/A	Gutter Lip Ht (in)	N/A	N/A	Gutter X Slope (%)	N/A
N/A	Painted X Walk1?	No	N/A	Painted X Walk2?	No
	X Walk 1 Direction	To NE		X Walk 2 Direction	To NW
N/A	X Walk 1 Width (in)	N/A	N/A	X Walk 2 Width (in)	N/A
	X Walk 1 Slope (%)	1.7		X Walk 2 Slope (%)	1.7
	X Walk 1 X Slope (%)	7.5		X Walk 2 X Slope (%)	0.9

N/A	Ramp inside XWalk1?	N/A	N/A	Ramp inside XWalk2?	N/A
	Road Slope (%)	4.5	N/A	Clear Space?	N/A
	Road X Slope (%)	2.4	N/A	Clear Space to XWalk (in)	N/A
N/A	Any Obstructions?	N/A	N/A	Storm Grate/Utility Hazard?	N/A
	Obstruction Type			Storm Grate/Utility Type	
		N/A			N/A
			Yes	Surface Condition? (G/P)	Good

**Remove & Replace Curb Ramp With Two New Directional Ramps or Equivalent.**

Total Cost: \$ 3200.00
