# Access Compliance Report

## Public Rights-of-Way

| Intersection ID: 24301 | Main Street: CARMEL_RD | Cross Street: GREEN_REA_RD | Location: S |
| ADA ID: 69ED6E4F09D1 | Ramp Type: PerpDiag | Initial Pass/Fail: Fail | Overall Compliance: No |

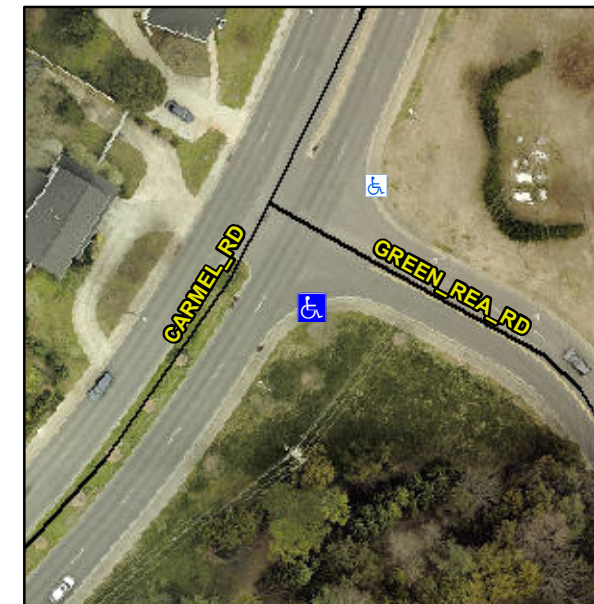
| Severity Score: 10 | | | |

**Not Found, R304.5.1, R304.5.3**

| Compliance | Description | Data | Compliance | Description | Data |
|---|---|---|---|---|---|
| N/A | Ramp Length (in) | 60.0 | Yes | Ramp Slope (%) | 6.9 |
| No | Ramp Width (in) | 45.0 | No | Ramp XSlope (%) | 2.1 |

**Remove & Replace Curb Ramp With Two New Directional Ramps or Equivalent.**

Total Cost: \$ 3200.00
