# Access Compliance Report

## Public Rights-of-Way

### (Curb Ramps)

| Intersection ID: 43967 | Main Street: BEAM_RD | Cross Street: CARRINGTON_OAKS_DR | Location: SW |

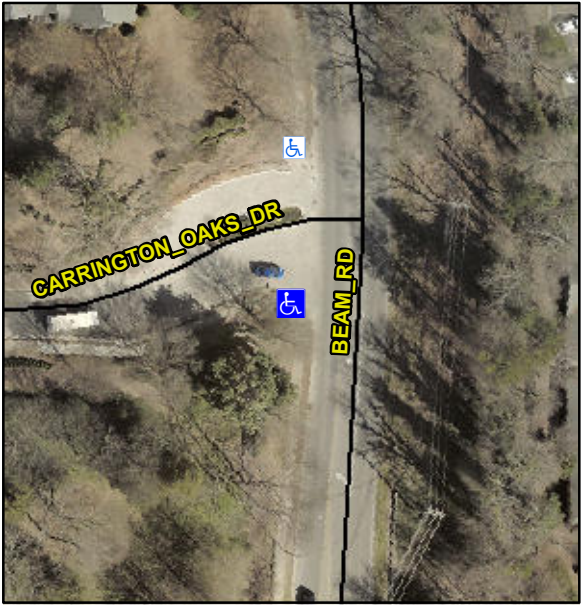
| ADA ID: 69F287137577 | Ramp Type: PerpDiag | Initial Pass/Fail: Fail | Overall Compliance: No |
| | | | Severity Score: 13.75 |

| Codes/Mitigation Info/Possible Solution | | | Field Measurements/Component Compliance | | |
|---|---|--|---|---|---|
| | <b>Remove &amp; Replace Curb Ramp With Two New Directional Ramps or Equivalent.</b> | | <b>No</b> | Ramp Length (in) | 44.0 |
| <p>Surveyor Notes:</p> <p><b>N/A</b></p> <p>PROW/ADA:</p> <p><b>Not Found, R304.2.2, R304.5.3</b></p> | | | <b>N/A</b> | Flare Type RT | N/A |
