Access Compliance Report

Public Rights-of-Way

(Curb Ramps)

Intersection ID: 10593	Main Street: BEATTIES_FORD_RD	Cross Street: ROZZELLES_FERRY_RD	Location: SE
ADA ID: 6A07699FDEBB	Ramp Type: Combination1	Initial Pass/Fail: Fail	Overall Compliance: No
Severity Score: 33.75

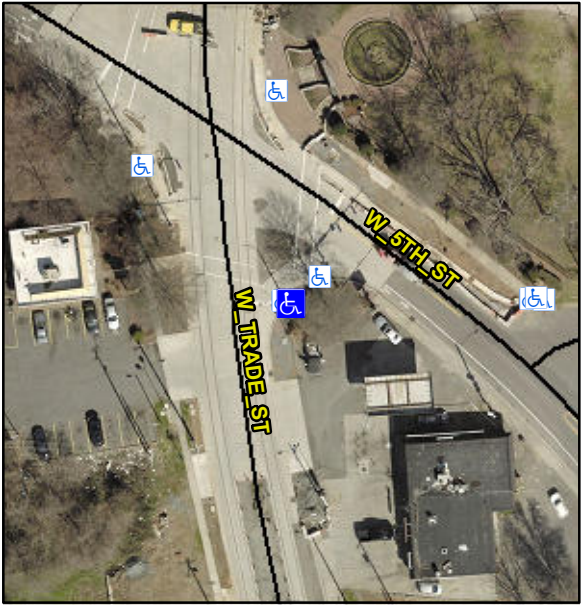
Possible Solutions:		Compliance	Description	Data
	Remove & Replace Entire Ramp.		N/A	Ramp Length LT (in)	32.0
			Yes	Ramp Width LT (in)	75.0
			No	Ramp Slope LT (%)	8.4
			Yes	Ramp XSlope LT (%)	0.8
			N/A	Ramp Length (in)	68.0
			No	Ramp Width (in)	39.5
	Surveyor Notes:		N/A	Flare Type LT	N/A
	N/A		N/A	Flare Slope LT (%)	N/A
			N/A	Flare Traversable LT?	N/A
<p>PROW/ADA:</p> <p>Not Found, R304.5.1, R304.2.2, R304.5.3, R304.3.2</p>			N/A	Landing Length (in)	N/A
			N/A	Landing Width (in)	N/A
			N/A	Landing Slope (%)	N/A
			N/A	Landing X Slope (%)	N/A
			N/A	Landing Curb? (Y/N)	N/A
			N/A	Shared Landing?	N/A
			N/A	Gutter Ponding?	N/A
			N/A	Gutter Lip Ht (in)	N/A
			N/A	Painted X Walk1?	Yes
				X Walk 1 Direction	To NW
<p>Street 1 Name</p> <p>Stop Condition-Street 1</p> <p>Street 2 Name</p> <p>Stop Condition-Street 2</p>				X Walk 1 Width (in)	132.0

X Walk 1 Slope (%)	2.7
				X Walk 1 X Slope (%)	5.8
			N/A	Ramp inside XWalk1?	Yes
				Road Slope (%)	N/A
				Road X Slope (%)	N/A
			N/A	Clear Space?	N/A
			N/A	Clear Space to XWalk (in)	N/A
			N/A	Any Obstruction?	N/A
				Obstruction Type	N/A
<p>Total Cost:</p> <p>\$ 1800.00</p>				Storm Grate/Utility Hazard?	N/A
				Storm Grate/Utility Type	N/A
					N/A
			Yes	Surface Condition? (G/P)	Good
				Curb Slope (%)	14.6
