Intersection ID: 4344		Main Street: MALLARD GROVE RD		Cross Street: POCHARD CT		Location:		NW					
ADA ID: 6A1E1047A27F		Ramp Type: Directional1		Initial Pass/Fail: Fail		Overall Compliance: No		Severity Score: 8.75					
Codes/Mitigation Info/Possible Solution				Field Measurements/Component Compliance									
		Possible Solutions:		Compliance		Description		Data					
		Remove & Replace Entire Ramp.		N/A		Ramp Length (in)		36.0					
				No		Ramp Width (in)		44.5					
				Yes		Ramp Slope (%)		5.3					
				Yes		Ramp XSlope (%)		0.2					
				N/A		Flare Type LT		N/A					
				N/A		Flare Slope LT (%)		N/A					
				N/A		Flare Traversable LT?		N/A					
				N/A		Landing Length (in)		0.0					
				N/A		Landing Width (in)		0.0					
Surveyor Notes:  N/A				N/A		Flare Type RT		N/A					
				N/A		Flare Slope RT (%)		0.0					
				N/A		Flare Traversable RT?		N/A					
				N/A		DWS Provided?		N/A					
				N/A		DWS Contrast?		N/A

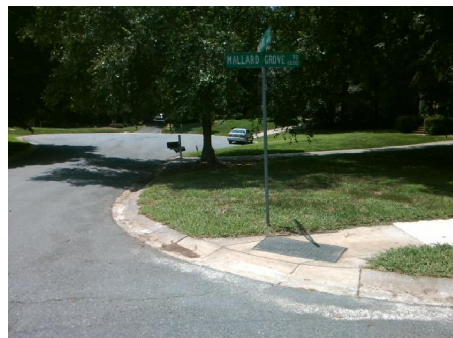
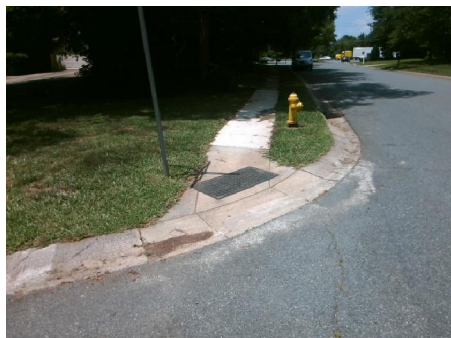
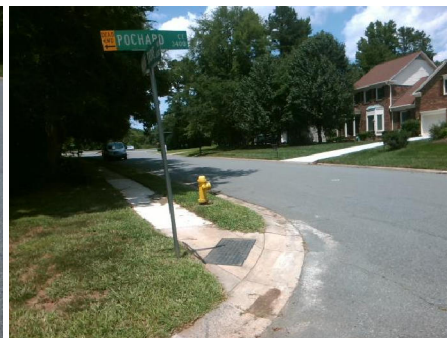
N/A		DWS Length (in)		N/A					
				N/A		DWS Full Width?		N/A					
				N/A		DWS Offset LT (in)		N/A					
				N/A		DWS Offset RT (in)		N/A					
				N/A		Gutter Slope (%)		N/A					
PROW/ADA:  R304.5.1				N/A		Gutter Lip Ht (in)		0.0					
				N/A		Gutter X Slope (%)		N/A					
				N/A		Painted X Walk1?		No					
						Road Slope (%)		2.0					
						Road X Slope (%)		3.1					
						Clear Space?		N/A					
						Clear Space to XWalk (in)		N/A					
						Storm Grate/Utility Hazard?		N/A					
						Storm Grate/Utility Type							
				N/A		Any Obstructions?		N/A					
Total Cost: \$ 1600.00				Obstruction Type		Yes		Surface Condition? (G/P)		Good			
						N/A		N/A		Curb Slope (%)		N/A
