Access Compliance Report

Public Rights-of-Way

(Curb Ramps)

Intersection ID: 53912	Main Street: BRITTONDALE_LN	Cross Street: PINYON_PINE_LN	Location: SE
ADA ID: 6A23A652B5C3	Ramp Type: PerpDiag	Initial Pass/Fail: Fail	Overall Compliance: No
		Severity Score: 10

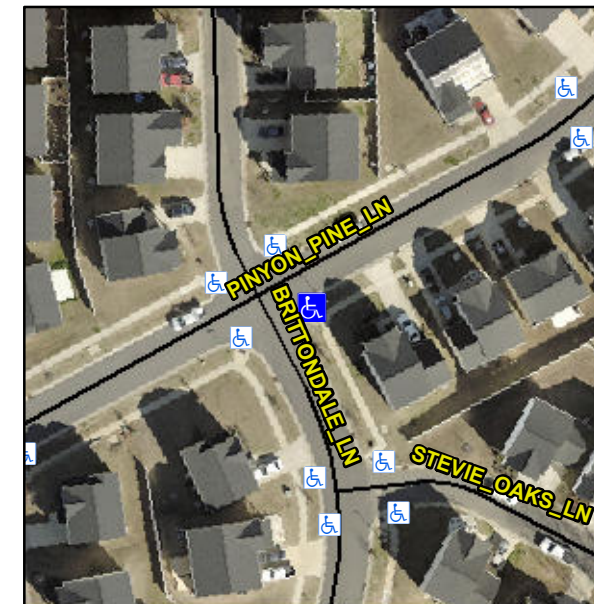
Not Found, R304.5.1, R304.5.3

Compliance	Description	Data	Compliance	Description	Data
N/A	Ramp Length (in)	100.0	Yes	Ramp Slope (%)	5.3
No	Ramp Width (in)	47.0	No	Ramp XSlope (%)	3.3
N/A	Flare Type LT	N/A	N/A	Flare Type RT	N/A
N/A	Flare Slope LT (%)	N/A	N/A	Flare Slope RT (%)	N/A
N/A	Flare Traversable LT?	N/A	N/A	Flare Traversable RT?	N/A
N/A	Landing Length (in)	N/A	N/A	DWS Provided?	N/A
N/A	Landing Width (in)	N/A	N/A	DWS Contrast?	N/A
N/A	Landing Slope (%)	N/A	N/A	DWS Length (in)	N/A
N/A	Landing X Slope (%)	N/A	N/A	DWS Full Width?	N/A
N/A	Landing Curb? (Y/N)	N/A	N/A	DWS Offset (in)	N/A
N/A	Shared Landing?	N/A			
N/A	Gutter Ponding?	N/A	N/A	Gutter Slope (%)	N/A
N/A	Gutter Lip Ht (in)	N/A	N/A	Gutter X Slope (%)	N/A
N/A	Painted X Walk1?	No	N/A	Painted X Walk2?	No
	X Walk 1 Direction	To N		X Walk 2 Direction	To W
N/A	X Walk 1 Width (in)	N/A	N/A	X Walk 2 Width (in)	N/A
	X Walk 1 Slope (%)	4.9		X Walk 2 Slope (%)	0.7
	X Walk 1 X Slope (%)	2.9		X Walk 2 X Slope (%)	1.9

N/A	Ramp inside XWalk1?	N/A	N/A	Ramp inside XWalk2?	N/A
	Road Slope (%)	1.7	N/A	Clear Space?	N/A
	Road X Slope (%)	1.3	N/A	Clear Space to XWalk (in)	N/A
N/A	Any Obstructions?	N/A	N/A	Storm Grate/Utility Hazard?	N/A
	Obstruction Type			Storm Grate/Utility Type	
		N/A			N/A
			Yes	Surface Condition? (G/P)	Good

Remove & Replace Curb Ramp With Two New Directional Ramps or Equivalent.
