# Access Compliance Report

## Public Rights-of-Way

### (Curb Ramps)

Intersection ID: 11481	Main Street: AFTON_LN	Cross Street: THORNTON_RD	Location: SW
ADA ID: 6A311571DE5B	Ramp Type: Perp	Initial Pass/Fail: Fail	Overall Compliance: No
Severity Score: 33.75			
Codes/Mitigation Info/Possible Solution		Field Measurements/Component Compliance

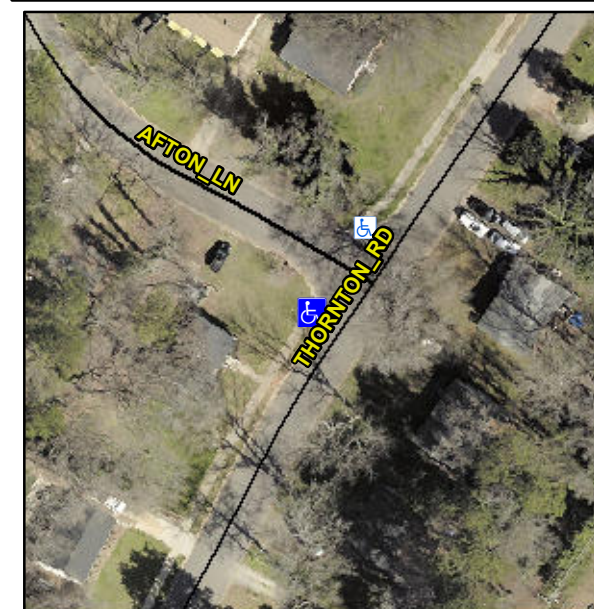
**Not Found, R304.5.1, R304.5.3**

Compliance	Description	Data	Compliance	Description	Data
N/A	Ramp Length (in)	49.5	Yes	Ramp Slope (%)	6.8
No	Ramp Width (in)	47.0	No	Ramp XSlope (%)	8.3
N/A	Flare Type LT	N/A	N/A	Flare Type RT	N/A
N/A	Flare Slope LT (%)	N/A	N/A	Flare Slope RT (%)	N/A
N/A	Flare Traversable LT?	N/A	N/A	Flare Traversable RT?	N/A
N/A	Landing Length (in)	N/A	N/A	DWS Provided?	N/A
N/A	Landing Width (in)	N/A	N/A	DWS Contrast?	N/A
N/A	Landing Slope (%)	N/A	N/A	DWS Length (in)	N/A
N/A	Landing X Slope (%)	N/A	N/A	DWS Full Width?	N/A
N/A	Landing Curb? (Y/N)	N/A	N/A	DWS Offset (in)	N/A
N/A	Shared Landing?	N/A			
N/A	Gutter Ponding?	N/A	N/A	Gutter Slope (%)	N/A
N/A	Gutter Lip Ht (in)	N/A	N/A	Gutter X Slope (%)	N/A
N/A	Painted X Walk1?	No	N/A	Painted X Walk2?	N/A
	X Walk 1 Direction	To NE		X Walk 2 Direction	N/A
N/A	X Walk 1 Width (in)	N/A	N/A	X Walk 2 Width (in)	N/A
	X Walk 1 Slope (%)	6.1		X Walk 2 Slope (%)	N/A
	X Walk 1 X Slope (%)	3.1		X Walk 2 X Slope (%)	N/A

N/A	Ramp inside XWalk1?	N/A	N/A	Ramp inside XWalk2?	N/A
	Road Slope (%)	N/A	N/A	Clear Space?	N/A
	Road X Slope (%)	N/A	N/A	Clear Space to XWalk (in)	N/A
N/A	Any Obstructions?	N/A	N/A	Storm Grate/Utility Hazard?	N/A
	Obstruction Type			Storm Grate/Utility Type	
		N/A			N/A
			Yes	Surface Condition? (G/P)	Good

**Remove & Replace Entire Ramp.**
