## **Access Compliance Report Public Rights-of-Way** (Curb Ramps)

Intersection ID: 9801 Main Street: ETHEL GUEST LN Cross Street: RISING OAK DR Location: SW **Overall Compliance: No Severity Score:** 60 ADA ID: 6A4476751D55 Ramp Type: PerpDiag Initial Pass/Fail: Fail

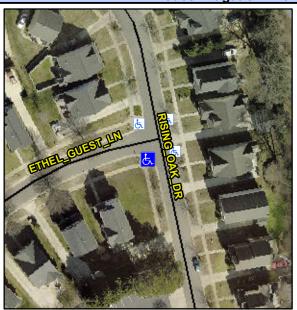
No No Ramp Width (in) 26.5 Ramp XSlope (%) N/A N/A Flare Type LT N/A Flare Type RT N/A N/A N/A Flare Slope RT (%) Flare Slope LT (%) Flare Traversable LT? N/A N/A Flare Traversable RT? N/A N/A **DWS Provided?** Landing Length (in) Landing Width (in) N/A N/A **DWS Contrast?** N/A N/A Landing Slope (%) DWS Length (in) Landing X Slope (%) N/A N/A DWS Full Width? Landing Curb? (Y/N) N/A N/A DWS Offset (in) N/A Shared Landing? **Gutter Ponding?** N/A N/A Gutter Slope (%) Gutter Lip Ht (in) 0.5 N/A Gutter X Slope (%) Painted X Walk1? No N/A Painted X Walk2? X Walk 1 Direction To E X Walk 2 Direction N/A X Walk 1 Width (in) X Walk 2 Width (in) X Walk 1 Slope (%) 3.7 X Walk 2 Slope (%) X Walk 1 X Slope (%) 2.3 X Walk 2 X Slope (%) N/A N/A Ramp inside XWalk2? Ramp inside XWalk1? Road Slope (%) 2.8 N/A Clear Space? N/A Road X Slope (%) 1.6 Clear Space to XWalk (in) N/A N/A Any Obstructions? Storm Grate/Utility Hazard? **Obstruction Type** Storm Grate/Utility Type

**RISING OAK DR** Street 1 Name Stop Condition-Street 2 None **ETHEL GUEST LN** Street 2 Name Stop Condition-Street 1 Signal Possible Solutions: Compliance Description N/A Remove & Replace Curb Ramp With Two New Directional Ramps or Equivalent. Surveyor Notes: N/A PROW/ADA: Not Found, R304.5.1, R304.5.3
