# Access Compliance Report

## Public Rights-of-Way

### (Curb Ramps)

Intersection ID: 50512	Main Street: EVERSFIELD_LN	Cross Street: MERIDALE_CROSSING_DR	Location: E
ADA ID: 6A4C331DF6AC	Ramp Type: PerpDiag	Initial Pass/Fail: Fail	Overall Compliance: No
Severity Score: 25			
Codes/Mitigation Info/Possible Solution		Field Measurements/Component Compliance

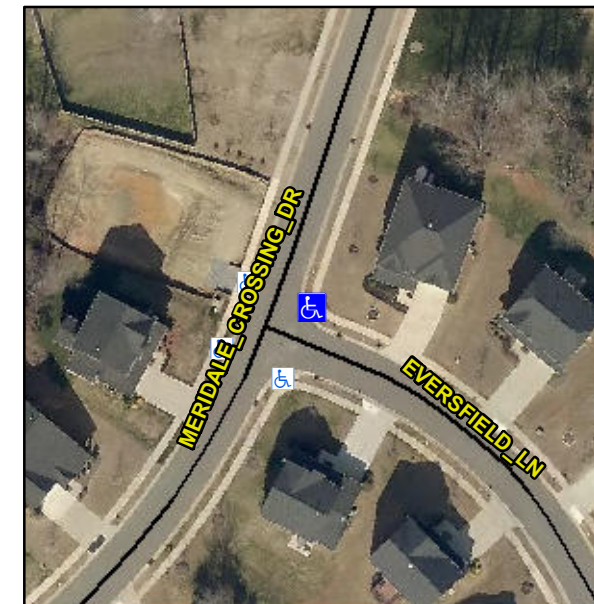
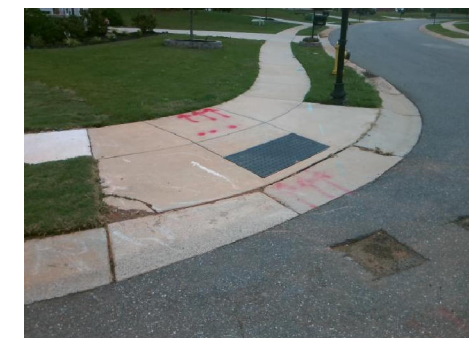
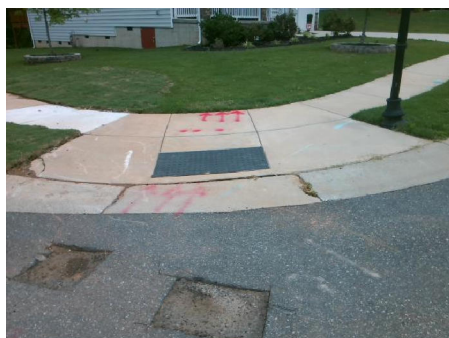
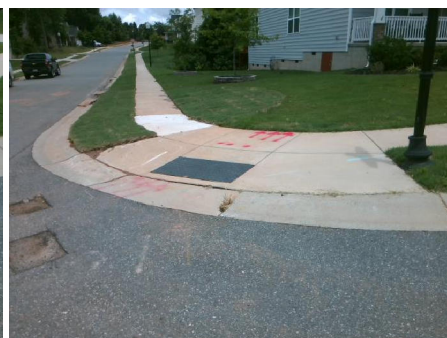
**R304.2.2, R304.5.3**

Compliance	Description	Data	Compliance	Description	Data
N/A	Ramp Length (in)	49.0	No	Ramp Slope (%)	8.9
Yes	Ramp Width (in)	48.0	No	Ramp XSlope (%)	5.2
N/A	Flare Type LT	N/A	N/A	Flare Type RT	N/A
N/A	Flare Slope LT (%)	N/A	N/A	Flare Slope RT (%)	N/A
N/A	Flare Traversable LT?	N/A	N/A	Flare Traversable RT?	N/A
N/A	Landing Length (in)	N/A	N/A	DWS Provided?	N/A
N/A	Landing Width (in)	N/A	N/A	DWS Contrast?	N/A
N/A	Landing Slope (%)	N/A	N/A	DWS Length (in)	N/A
N/A	Landing X Slope (%)	N/A	N/A	DWS Full Width?	N/A
N/A	Landing Curb? (Y/N)	N/A	N/A	DWS Offset (in)	N/A
N/A	Shared Landing?	N/A			
N/A	Gutter Ponding?	N/A	N/A	Gutter Slope (%)	N/A
N/A	Gutter Lip Ht (in)	N/A	N/A	Gutter X Slope (%)	N/A
N/A	Painted X Walk1?	No	N/A	Painted X Walk2?	No
	X Walk 1 Direction	To NW		X Walk 2 Direction	To SW
N/A	X Walk 1 Width (in)	N/A	N/A	X Walk 2 Width (in)	N/A
	X Walk 1 Slope (%)	0.8		X Walk 2 Slope (%)	1.1
	X Walk 1 X Slope (%)	4.8		X Walk 2 X Slope (%)	2.5

N/A	Ramp inside XWalk1?	N/A	N/A	Ramp inside XWalk2?	N/A
	Road Slope (%)	4.6	N/A	Clear Space?	N/A
	Road X Slope (%)	0.9	N/A	Clear Space to XWalk (in)	N/A
N/A	Any Obstructions?	N/A	N/A	Storm Grate/Utility Hazard?	N/A
	Obstruction Type			Storm Grate/Utility Type	
		N/A			N/A
			Yes	Surface Condition? (G/P)	Good

Possible Solutions:

**Remove & Replace Curb Ramp With Two New Directional Ramps or Equivalent.**
