# Access Compliance Report

## Public Rights-of-Way

| Intersection ID: 14652 | Main Street: DRIFTWOOD_DR | Cross Street: MCMANUS_DR | Location: SE |
| ADA ID: 6A4DBCA61F76 | Ramp Type: Directional1 | Initial Pass/Fail: Pass | Overall Compliance: No |

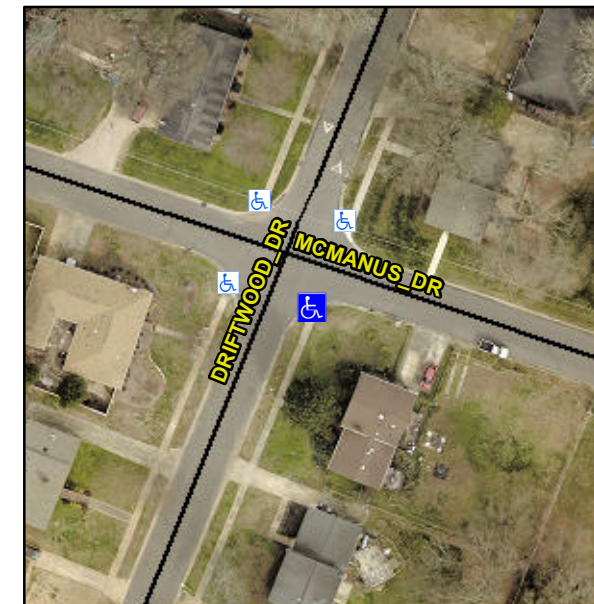
**Not Found, R304.2.1, R304.5.3,  
R305.1.4, R305.2**

| Compliance | Description | Data | Compliance | Description | Data |
|---|---|---|---|---|---|
| Yes | Ramp Slope (%) | 1.2 | No | Grade Break XSlope (%) | 3.4 |
| No | Landing Length (in) | 47.5 | Yes | DWS Provided? | Yes |
| No | Landing Width (in) | 47.5 | Yes | DWS Contrast? | Yes |
| No | Landing X Slope (%) | 2.2 | No | DWS Full Width? | No |
| N/A | Shared Landing? | No | No | DWS Offset RT (in) | 3.5 |
| Yes | Gutter Lip Ht (in) | 0.0 | No | Gutter X Slope (%) | 3.0 |

**Remove & Replace Entire Ramp.  
Remove & Replace Gutter.**
