## Access Compliance Report Public Rights-of-Way (Curb Ramps)

Intersection ID: 3977 Main Street: FOUNTAINGROVE\_DR Cross Street: GALLOWAY\_RD Location: E

ADA ID: 6A6ED23ACB38 Ramp Type: PerpDiag Initial Pass/Fail: Fail Overall Compliance: No Severity Score: 47.5

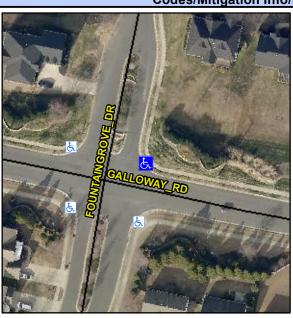
Not Found, R304.5.1, R304.2.2

Fleid Measurements/Component Compliance						
	Compliance Description		Data	Compl	iance Description	Data
	N/A	Ramp Length (in)	42.0	No	Ramp Slope (%)	9.8
	No	Ramp Width (in)	30.0	Yes	Ramp XSlope (%)	1.7
	N/A	Flare Type LT	N/A	N/A	Flare Type RT	N/A
	N/A	Flare Slope LT (%)	N/A	N/A	Flare Slope RT (%)	N/A
	N/A	Flare Traversable LT?	N/A	N/A	Flare Traversable RT?	N/A
	N/A	Landing Length (in)	N/A	N/A	DWS Provided?	N/A
	N/A	Landing Width (in)	N/A	N/A	DWS Contrast?	N/A
	N/A	Landing Slope (%)	N/A	N/A	DWS Length (in)	N/A
	N/A	Landing X Slope (%)	N/A	N/A	DWS Full Width?	N/A
	N/A	Landing Curb? (Y/N)	N/A	N/A	DWS Offset (in)	N/A
	N/A	Shared Landing?	N/A			
	N/A	Gutter Ponding?	N/A	N/A	Gutter Slope (%)	N/A
	N/A	Gutter Lip Ht (in)	N/A	N/A	Gutter X Slope (%)	N/A
	N/A	Painted X Walk1?	No	N/A	Painted X Walk2?	No
		X Walk 1 Direction	To NW		X Walk 2 Direction	To SW
	N/A	X Walk 1 Width (in)	N/A	N/A	X Walk 2 Width (in)	N/A
		X Walk 1 Slope (%)	5.0		X Walk 2 Slope (%)	3.2

X Walk 1 X Slope (%)	1.1		X Walk 2 X Slope (%)	3.6
	N/A	Ramp inside XWalk1?	N/A	N/A	Ramp inside XWalk2?	N/A
		Road Slope (%)	1.7	N/A	Clear Space?	N/A
		Road X Slope (%)	3.3	N/A	Clear Space to XWalk (in)	N/A
	N/A	Any Obstructions?	N/A	N/A	Storm Grate/Utility Hazard?	N/A

Remove & Replace Curb Ramp With Two New Directional Ramps or Equivalent.

Total Cost: \$ 3200.00
