## Access Compliance Report Public Rights-of-Way (Curb Ramps)

Intersection ID: 15279	D: 15279 Main Street: COLVILLE_RD				S DOTGER AV	Location:	NE		
			Cross Street: S_DOTGER_AV						
ADA ID: 6A721DDAD82E	1DDAD82E Ramp Type: PerpDiag		Initial Pass/Fail: Fail Overall Compliance: No				Severity Score:	25	
Codes/Mitigation Info/Possible Solution				Field Measurements/Component Compliance					
	1-1	Possible Solutions:		Compliance Description		Data Compliance Description			Data
1 Contraction		Remove & Replace Curb Ramp W	/ith	N/A	Ramp Length (in)	77.0	No	Ramp Slope (%)	13.4
		Two New Directional Ramps or		Yes	Ramp Width (in)	48.0	Yes	Ramp XSlope (%)	2.0
	in a las	Equivalent.		N/A	Flare Type LT	N/A	N/A	Flare Type RT	N/A
	mi S/			N/A	Flare Slope LT (%)	N/A	N/A	Flare Slope RT (%)	N/A
AT LEAST	AT I			N/A	Flare Traversable LT?	N/A	N/A	Flare Traversable RT?	N/A
	3			N/A	Landing Length (in)	N/A	N/A	DWS Provided?	N/A
		Surveyor Notes:		N/A	Landing Width (in)	N/A	N/A	DWS Contrast?	N/A

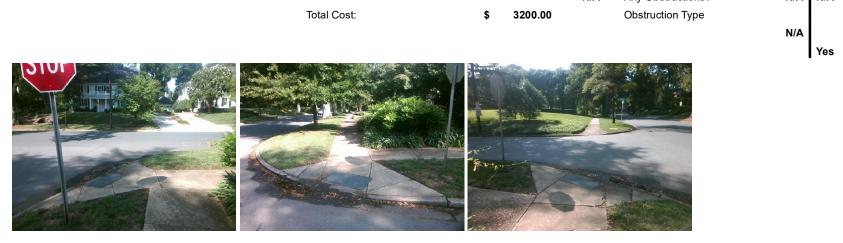
N/A		N/A	Landing Slope (%)	N/A	N/A	DWS Length (in)	N/A
				N/A	Landing X Slope (%)	N/A	N/A	DWS Full Width?	N/A
L C				N/A	Landing Curb? (Y/N)	N/A	N/A	DWS Offset (in)	N/A
				N/A	Shared Landing?	N/A			
		PROW/ADA:		N/A	Gutter Ponding?	N/A	N/A	Gutter Slope (%)	N/A
A STAR		Not Found, R304.2.2		N/A	Gutter Lip Ht (in)	N/A	N/A	Gutter X Slope (%)	N/A
				N/A	Painted X Walk1?	No	N/A	Painted X Walk2?	No
and the state	1 10 332				X Walk 1 Direction	To SW		X Walk 2 Direction	To SE
AST BALLAND	1.4			N/A	X Walk 1 Width (in)	N/A	N/A	X Walk 2 Width (in)	N/A
Street 1 Name	COLVILLE RD	-			X Walk 1 Slope (%)	0.4		X Walk 2 Slope (%)	1.8
Stop Condition-Street 2	None				X Walk 1 X Slope (%)	1.8		X Walk 2 X Slope (%)	1.7
Street 2 Name	S DOTGER AV			N/A	Ramp inside XWalk1?	N/A	N/A	Ramp inside XWalk2?	N/A
Stop Condition-Street 1	StopSign				Road Slope (%)	0.7	N/A	Clear Space?	N/A
	_				Road X Slope (%)	2.4	N/A	Clear Space to XWalk (in)	N/A

Good
