Access Compliance Report

Public Rights-of-Way

(Curb Ramps)

Intersection ID: 29756	Main Street: KING_ARTHUR_DR	Cross Street: NIMUE_CT	Location: W
ADA ID: 6A7FD456C75B	Ramp Type: BlendTrans2	Initial Pass/Fail: Fail	Overall Compliance: No
Severity Score: 17.5			
Codes/Mitigation Info/Possible Solution		Field Measurements/Component Compliance

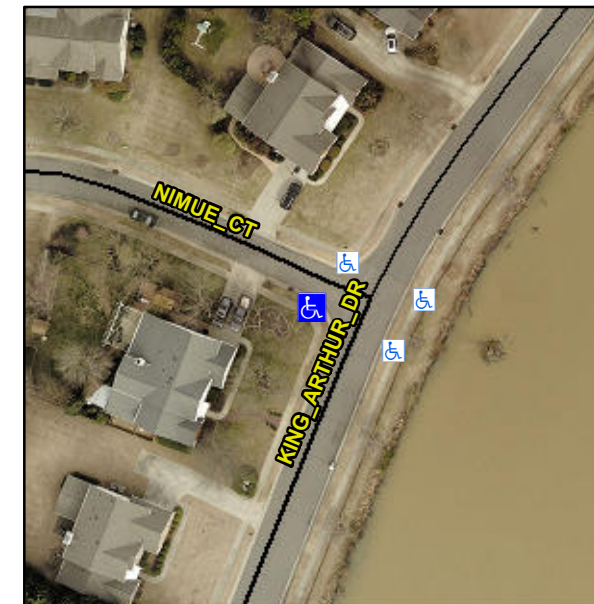
Not Found, R304.5.1

Compliance	Description	Data	Compliance	Description	Data
N/A	Ramp Length (in)	47.0	Yes	BlendTrans Slope (%)	4.5
No	Ramp Width (in)	35.0	Yes	BlendTrans XSlope (%)	0.7
N/A	Flare Type LT	N/A	N/A	Flare Type RT	N/A
N/A	Flare Slope LT (%)	N/A	N/A	Flare Slope RT (%)	N/A
N/A	Flare Traversable LT?	N/A	N/A	Flare Traversable RT?	N/A
N/A	Landing Length (in)	N/A	N/A	DWS Provided?	N/A
N/A	Landing Width (in)	N/A	N/A	DWS Contrast?	N/A
N/A	Landing Slope (%)	N/A	N/A	DWS Length (in)	N/A
N/A	Landing X Slope (%)	N/A	N/A	DWS Full Width?	N/A
N/A	Landing Curb? (Y/N)	N/A	N/A	DWS Offset (in)	N/A
N/A	Shared Landing?	N/A			
N/A	Gutter Ponding?	N/A	N/A	Gutter Slope (%)	N/A
N/A	Gutter Lip Ht (in)	N/A	N/A	Gutter X Slope (%)	N/A
N/A	Painted X Walk1?	No	N/A	Painted X Walk2?	No
	X Walk 1 Direction	To SE		X Walk 2 Direction	To NE
	X Walk 1 Width (in)	N/A		X Walk 2 Width (in)	N/A
	X Walk 1 Slope (%)	0.0		X Walk 2 Slope (%)	0.5
	X Walk 1 X Slope (%)	0.6		X Walk 2 X Slope (%)	0.2

N/A	Ramp inside XWalk1?	N/A	N/A	Ramp inside XWalk2?	N/A
	Road Slope (%)	0.3		Clear Space?	N/A
	Road X Slope (%)	2.2	N/A	Clear Space to XWalk (in)	N/A
N/A	Any Obstructions?	N/A	N/A	Storm Grate/Utility Hazard?	N/A
	Obstruction Type			Storm Grate/Utility Type	
		N/A			N/A
			Yes	Surface Condition? (G/P)	Good
			No	Curb Slope (%)	21.7

Remove & Replace Curb Ramp With Two New Directional Ramps or Equivalent.
