# Access Compliance Report

## Public Rights-of-Way

### (Curb Ramps)

Intersection ID: 10022367	Main Street: CAMFIELD_ST	Cross Street: N/A	Location: NW
ADA ID: 6A837FB5DC06	Ramp Type: PerpDiag	Initial Pass/Fail: Fail	Overall Compliance: No
		Severity Score: 8.75

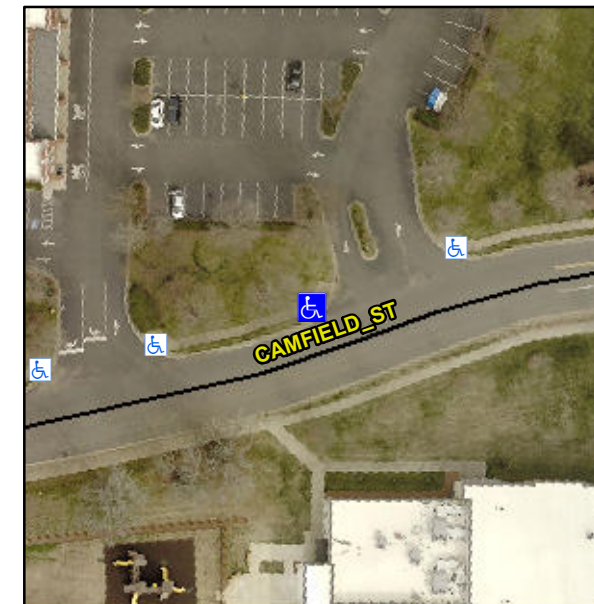
**Not Found, R304.5.1**

Compliance	Description	Data	Compliance	Description	Data
N/A	Ramp Length (in)	95.0	Yes	Ramp Slope (%)	5.3
No	Ramp Width (in)	43.0	Yes	Ramp XSlope (%)	1.7
N/A	Flare Type LT	N/A	N/A	Flare Type RT	N/A
N/A	Flare Slope LT (%)	N/A	N/A	Flare Slope RT (%)	N/A
N/A	Flare Traversable LT?	N/A	N/A	Flare Traversable RT?	N/A
N/A	Landing Length (in)	N/A	N/A	DWS Provided?	N/A
N/A	Landing Width (in)	N/A	N/A	DWS Contrast?	N/A
N/A	Landing Slope (%)	N/A	N/A	DWS Length (in)	N/A
N/A	Landing X Slope (%)	N/A	N/A	DWS Full Width?	N/A
N/A	Landing Curb? (Y/N)	N/A	N/A	DWS Offset (in)	N/A
N/A	Shared Landing?	N/A			
N/A	Gutter Ponding?	N/A	N/A	Gutter Slope (%)	N/A
N/A	Gutter Lip Ht (in)	N/A	N/A	Gutter X Slope (%)	N/A
N/A	Painted X Walk1?	No	N/A	Painted X Walk2?	No
	X Walk 1 Direction	To S		X Walk 2 Direction	To E
N/A	X Walk 1 Width (in)	N/A	N/A	X Walk 2 Width (in)	N/A
	X Walk 1 Slope (%)	1.9		X Walk 2 Slope (%)	1.4
	X Walk 1 X Slope (%)	2.8		X Walk 2 X Slope (%)	0.5

N/A	Ramp inside XWalk1?	N/A	N/A	Ramp inside XWalk2?	N/A
	Road Slope (%)	0.5	N/A	Clear Space?	N/A
	Road X Slope (%)	2.4	N/A	Clear Space to XWalk (in)	N/A
N/A	Any Obstructions?	N/A	N/A	Storm Grate/Utility Hazard?	N/A
	Obstruction Type			Storm Grate/Utility Type	
		N/A			N/A
			Yes	Surface Condition? (G/P)	Good

**Remove & Replace Curb Ramp With Two New Directional Ramps or Equivalent.**
