# Access Compliance Report

## Public Rights-of-Way

| Intersection ID: 23633 | Main Street: HILLSIDE_LN | Cross Street: LARRISA_CT | Location: SW |
| ADA ID: 6A86EE4B5758 | Ramp Type: BlendTrans2 | Initial Pass/Fail: Fail | Overall Compliance: No |

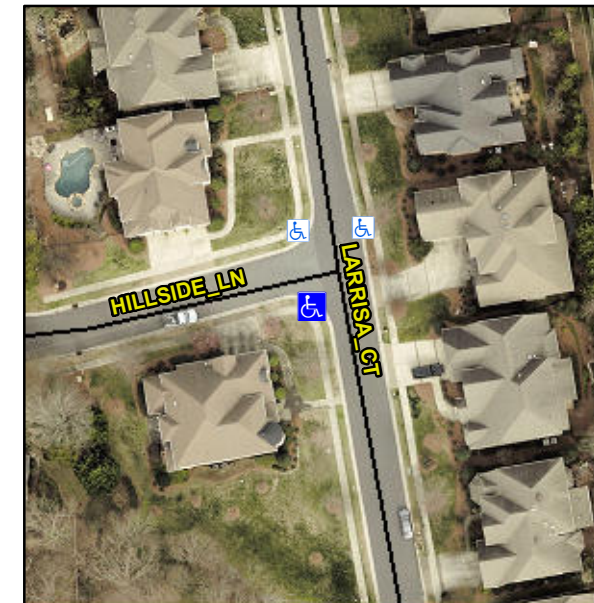
| | | Severity Score: 8.75 | |

**Not Found, R304.5.1**

| Compliance | Description | Data | Compliance | Description | Data |
|---|---|---|---|---|---|
| No | Ramp Width (in) | 37.0 | Yes | BlendTrans XSlope (%) | 1.0 |
| | | | No | Curb Slope (%) | 13.0 |

**Remove & Replace Curb Ramp With Two New Directional Ramps or Equivalent.**

Total Cost: \$ 3200.00

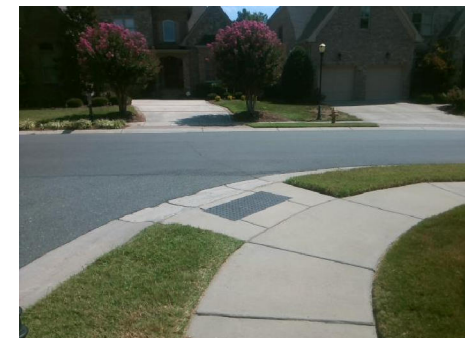
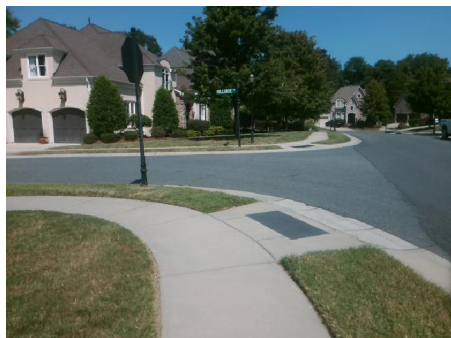
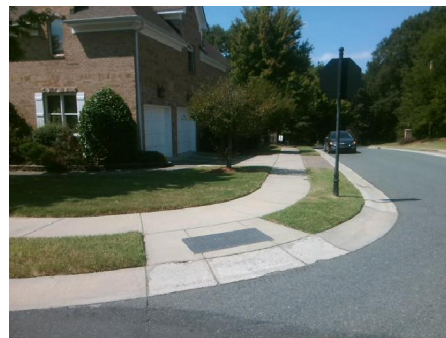
Street 1 Name LARRISA CT  
 Stop Condition-Street 1 None  
 Street 2 Name HILLSIDE LN  
 Stop Condition-Street 2 StopSign
