Access Compliance Report

Public Rights-of-Way

(Curb Ramps)

| Intersection ID: 29693 | Main Street: OAKTON_RIDGE_CT | Cross Street: WEDDINGTON_RIDGE_LN | Location: E |

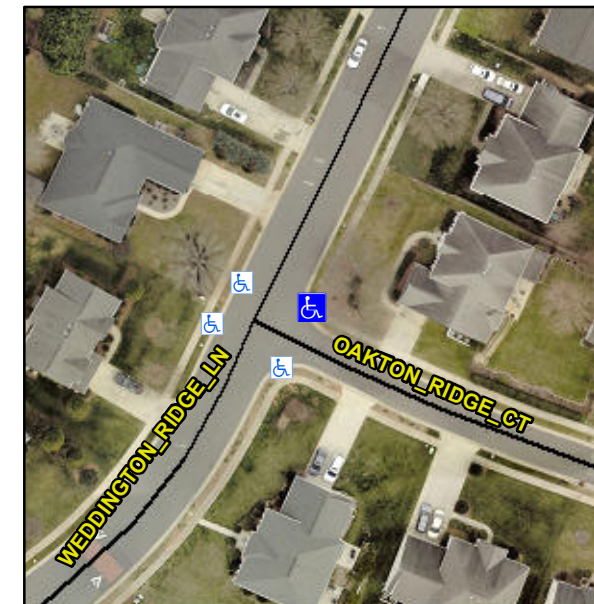
| ADA ID: 6A8B5EFADFCB | Ramp Type: BlendTrans1 | Initial Pass/Fail: Fail | Overall Compliance: No |

| Compliance | Description | Data | Compliance | Description | Data |
|---|---|---|---|---|---|
| No | Ramp Width (in) | 31.0 | Yes | BlendTrans XSlope (%) | 1.7 |

Remove & Replace Curb Ramp With Two New Directional Ramps or Equivalent.
