Access Compliance Report Public Rights-of-Way (Curb Ramps)

Intersection ID: 44109Main Street: TRAHERNE_CTCross Street: STAFFORDSHIRE_LNLocation:SWADA ID: 6A9ACE45D7D2Ramp Type: BlendTrans1Initial Pass/Fail: FailOverall Compliance: NoSeverity Score:10

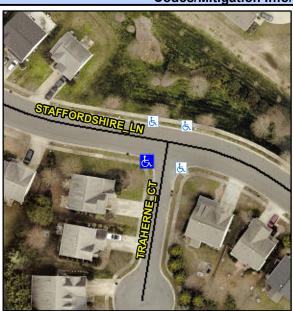
Field Measurements/Component Compnance					
Compliance Description Da		Data	Compliance Description		Data
N/A	Ramp Length (in)	49.0	Yes	BlendTrans Slope (%)	3.2
No	Ramp Width (in)	47.5	Yes	BlendTrans XSlope (%)	3.0
N/A	Flare Type LT	N/A	N/A	Flare Type RT	N/A
N/A	Flare Slope LT (%)	N/A	N/A	Flare Slope RT (%)	N/A
N/A	Flare Traversable LT?	N/A	N/A	Flare Traversable RT?	N/A
N/A	Landing Length (in)	N/A	N/A	DWS Provided?	N/A
N/A	Landing Width (in)	N/A	N/A	DWS Contrast?	N/A
N/A	Landing Slope (%)	N/A	N/A	DWS Length (in)	N/A
N/A	Landing X Slope (%)	N/A	N/A	DWS Full Width?	N/A
N/A	Landing Curb? (Y/N)	N/A	N/A	DWS Offset (in)	N/A
N/A	Shared Landing?	N/A			
N/A	Gutter Ponding?	N/A	N/A	Gutter Slope (%)	N/A
N/A	Gutter Lip Ht (in)	N/A	N/A	Gutter X Slope (%)	N/A
N/A	Painted X Walk1?	No	N/A	Painted X Walk2?	No
	X Walk 1 Direction	To SE		X Walk 2 Direction	To NW
	X Walk 1 Width (in)	N/A		X Walk 2 Width (in)	N/A
	X Walk 1 Slope (%)	5.7		X Walk 2 Slope (%)	0.4

X Walk 1 X Slope (%)	1.8		X Walk 2 X Slope (%)	6.7
N/A	Ramp inside XWalk1?	N/A	N/A	Ramp inside XWalk2?	N/A
	Road Slope (%)	4.1		Clear Space?	N/A
	Road X Slope (%)	4.7	N/A	Clear Space to XWalk (in)	N/A
N/A	Any Obstructions?	N/A	N/A	Storm Grate/Utility Hazard?	N/A
	Obstruction Type			Storm Grate/Utility Type	
		N/A			N/A
			Yes	Surface Condition? (G/P)	Good
1000			No	Curb Slope (%)	15.1

Remove & Replace Curb Ramp With Two New Directional Ramps or Equivalent.

Not Found, R304.5.1
