# Access Compliance Report

## Public Rights-of-Way

### (Curb Ramps)

Intersection ID: 46689	Main Street: GOLDFIELDS_DR	Cross Street: NIGHTSHADE_OAKS_DR	Location: SE
ADA ID: 6A9B496CC577	Ramp Type: PerpDiag	Initial Pass/Fail: Fail	Overall Compliance: No
Severity Score: 13.75			
Codes/Mitigation Info/Possible Solution		Field Measurements/Component Compliance

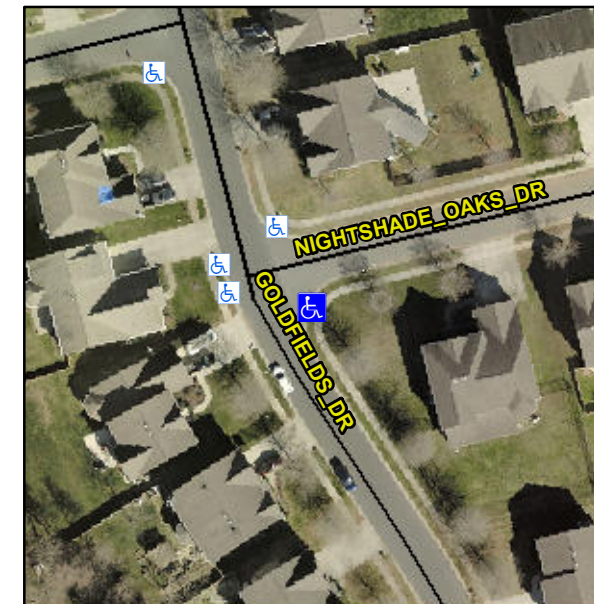
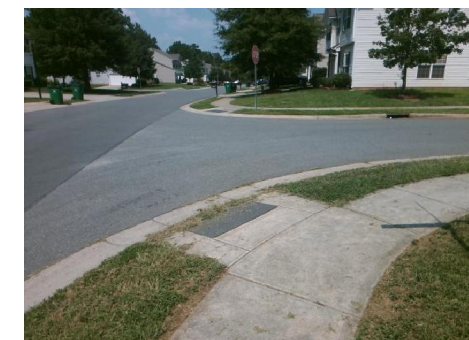
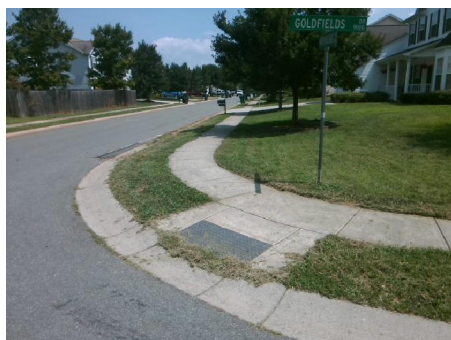
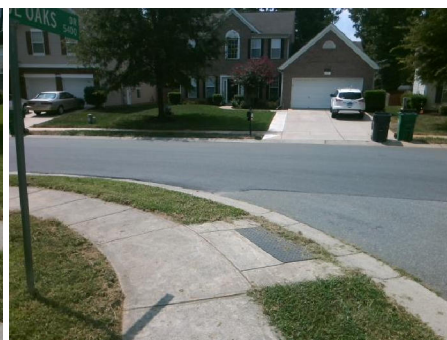
**Not Found, R304.2.2, R304.5.3**

Compliance	Description	Data	Compliance	Description	Data
N/A	Ramp Length (in)	48.0	No	Ramp Slope (%)	9.6
Yes	Ramp Width (in)	48.0	No	Ramp XSlope (%)	3.8
N/A	Flare Type LT	N/A	N/A	Flare Type RT	N/A
N/A	Flare Slope LT (%)	N/A	N/A	Flare Slope RT (%)	N/A
N/A	Flare Traversable LT?	N/A	N/A	Flare Traversable RT?	N/A
N/A	Landing Length (in)	N/A	N/A	DWS Provided?	N/A
N/A	Landing Width (in)	N/A	N/A	DWS Contrast?	N/A
N/A	Landing Slope (%)	N/A	N/A	DWS Length (in)	N/A
N/A	Landing X Slope (%)	N/A	N/A	DWS Full Width?	N/A
N/A	Landing Curb? (Y/N)	N/A	N/A	DWS Offset (in)	N/A
N/A	Shared Landing?	N/A			
N/A	Gutter Ponding?	N/A	N/A	Gutter Slope (%)	N/A
N/A	Gutter Lip Ht (in)	N/A	N/A	Gutter X Slope (%)	N/A
N/A	Painted X Walk1?	No	N/A	Painted X Walk2?	No
	X Walk 1 Direction	To NE		X Walk 2 Direction	To NW
N/A	X Walk 1 Width (in)	N/A	N/A	X Walk 2 Width (in)	N/A
	X Walk 1 Slope (%)	2.2		X Walk 2 Slope (%)	4.7
	X Walk 1 X Slope (%)	0.5		X Walk 2 X Slope (%)	2.3

N/A	Ramp inside XWalk1?	N/A	N/A	Ramp inside XWalk2?	N/A
	Road Slope (%)	0.1	N/A	Clear Space?	N/A
	Road X Slope (%)	1.6	N/A	Clear Space to XWalk (in)	N/A
N/A	Any Obstructions?	N/A	N/A	Storm Grate/Utility Hazard?	N/A
	Obstruction Type			Storm Grate/Utility Type	
		N/A			N/A
			Yes	Surface Condition? (G/P)	Good

**Remove & Replace Curb Ramp With Two New Directional Ramps or Equivalent.**
