Access Compliance Report

Public Rights-of-Way

(Curb Ramps)

Intersection ID: 51721	Main Street: PROVIDENCE_RD_WEST	Cross Street: BALLANCROFT_PY	Location: NW
ADA ID: 6A9DA3FF6CA5	Ramp Type: Perp	Initial Pass/Fail: Fail	Overall Compliance: No
Severity Score: 1.25			
Codes/Mitigation Info/Possible Solution		Field Measurements/Component Compliance

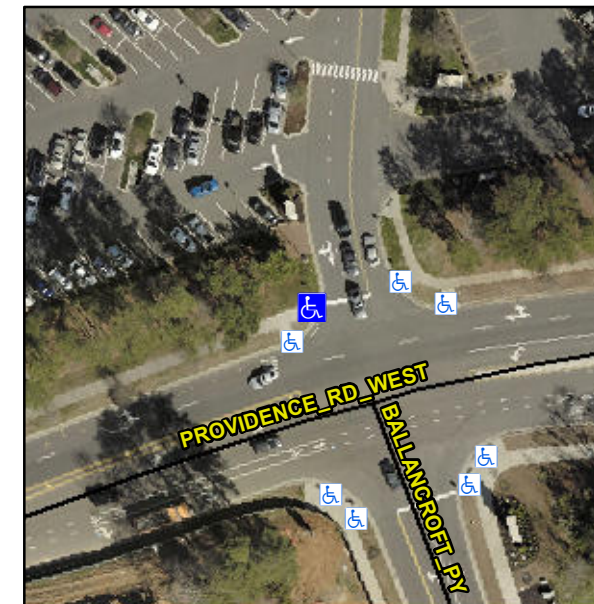
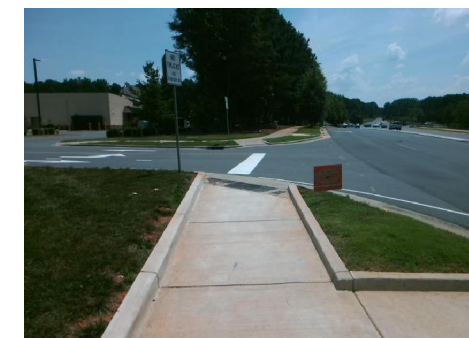
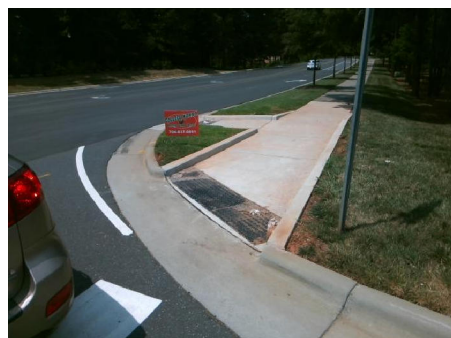
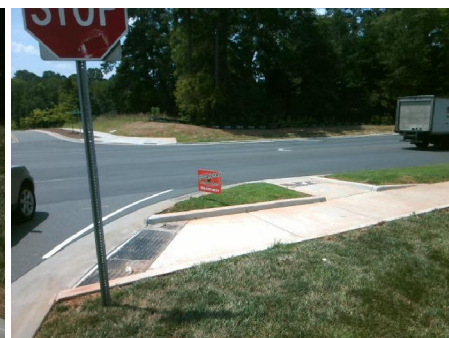
Compliance	Description	Data	Compliance	Description	Data
N/A	Ramp Length (in)	168.0	Yes	Ramp Slope (%)	5.9
Yes	Ramp Width (in)	74.0	No	Ramp XSlope (%)	3.5
N/A	Flare Type LT	N/A	N/A	Flare Type RT	N/A
N/A	Flare Slope LT (%)	N/A	N/A	Flare Slope RT (%)	N/A
N/A	Flare Traversable LT?	N/A	N/A	Flare Traversable RT?	N/A
N/A	Landing Length (in)	N/A	N/A	DWS Provided?	N/A
N/A	Landing Width (in)	N/A	N/A	DWS Contrast?	N/A
N/A	Landing Slope (%)	N/A	N/A	DWS Length (in)	N/A
N/A	Landing X Slope (%)	N/A	N/A	DWS Full Width?	N/A
N/A	Landing Curb? (Y/N)	N/A	N/A	DWS Offset (in)	N/A
N/A	Shared Landing?	N/A			
N/A	Gutter Ponding?	N/A	N/A	Gutter Slope (%)	N/A
N/A	Gutter Lip Ht (in)	N/A	N/A	Gutter X Slope (%)	N/A
N/A	Painted X Walk1?	No	N/A	Painted X Walk2?	N/A
	X Walk 1 Direction	To E		X Walk 2 Direction	N/A
N/A	X Walk 1 Width (in)	N/A	N/A	X Walk 2 Width (in)	N/A
	X Walk 1 Slope (%)	3.2		X Walk 2 Slope (%)	N/A
	X Walk 1 X Slope (%)	4.0		X Walk 2 X Slope (%)	N/A

Possible Solutions:

Remove & Replace Entire Ramp.
