# Access Compliance Report

## Public Rights-of-Way

### (Curb Ramps)

| Intersection ID: 9578 | Main Street: WOODWARD_AV | Cross Street: STATESVILLE_AV | Location: NW |

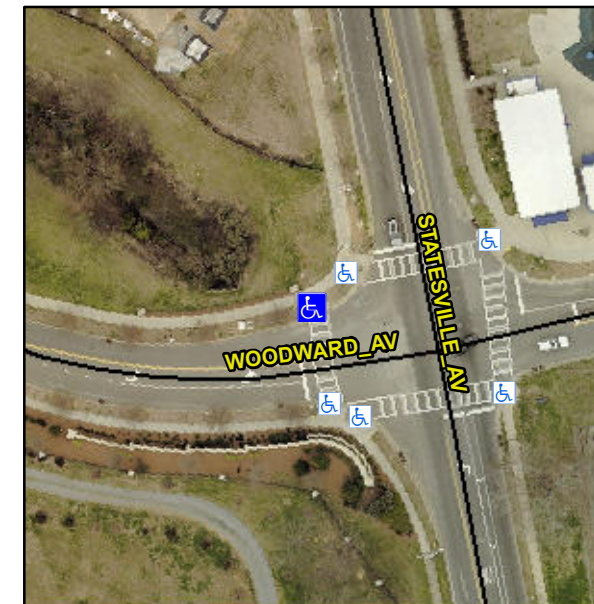
| ADA ID: 6AACC8827C8C | Ramp Type: Perp | Initial Pass/Fail: Fail | Overall Compliance: No |

**Not Found, R304.5.1, R304.2.2**

| Compliance | Description | Data | Compliance | Description | Data |
|---|---|---|---|---|---|
| N/A | Ramp Length (in) | 96.5 | No | Ramp Slope (%) | 9.2 |
| No | Ramp Width (in) | 45.0 | Yes | Ramp XSlope (%) | 1.0 |

**Remove & Replace Entire Ramp.**

Total Cost: \$ 1850.00
