# Access Compliance Report

## Public Rights-of-Way

### (Curb Ramps)

Intersection ID: 9362	Main Street: DELTA LAKE DR	Cross Street: ROCKMOOR RIDGE RD	Location: NW
ADA ID: 6AC3315AFDE4	Ramp Type: Perp	Initial Pass/Fail: Fail	Overall Compliance: No
			Severity Score: 13.75

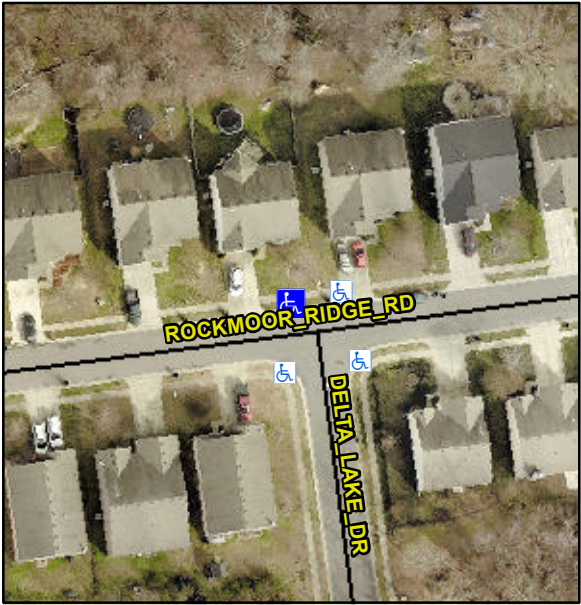
Possible Solutions:						
	Remove & Replace Entire Ramp.						
		Compliance	Description	Data	Compliance	Description	Data
		N/A	Ramp Length (in)	48.0	No	Ramp Slope (%)	9.8
		Yes	Ramp Width (in)	48.0	Yes	Ramp XSlope (%)	3.1
		N/A	Flare Type LT	N/A	N/A	Flare Type RT	N/A
		N/A	Flare Slope LT (%)	N/A	N/A	Flare Slope RT (%)	N/A
		N/A	Flare Traversable LT?	N/A	N/A	Flare Traversable RT?	N/A
		N/A	Landing Length (in)	N/A	N/A	DWS Provided?	N/A
		N/A	Landing Width (in)	N/A	N/A	DWS Contrast?	N/A
<p>Surveyor Notes:</p> <p>N/A</p>		N/A	Landing Slope (%)	N/A	N/A	DWS Length (in)	N/A
		N/A	Landing X Slope (%)	N/A	N/A	DWS Full Width?	N/A
		N/A	Landing Curb? (Y/N)	N/A	N/A	DWS Offset (in)	N/A
		N/A	Shared Landing?	N/A			
		N/A	Gutter Ponding?	N/A	N/A	Gutter Slope (%)	N/A
		N/A	Gutter Lip Ht (in)	N/A	N/A	Gutter X Slope (%)	N/A
		N/A	Painted X Walk1?	No	N/A	Painted X Walk2?	N/A

X Walk 1 Direction	To S		X Walk 2 Direction	N/A
		N/A	X Walk 1 Width (in)	N/A	N/A	X Walk 2 Width (in)	N/A
			X Walk 1 Slope (%)	2.1		X Walk 2 Slope (%)	N/A
<p>PROW/ADA:</p> <p>Not Found, R304.2.2</p>			X Walk 1 X Slope (%)	3.1		X Walk 2 X Slope (%)	N/A
		N/A	Ramp inside XWalk1?	N/A	N/A	Ramp inside XWalk2?	N/A
			Road Slope (%)	N/A	N/A	Clear Space?	N/A
			Road X Slope (%)	N/A	N/A	Clear Space to XWalk (in)	N/A
		N/A	Any Obstructions?	N/A	N/A	Storm Grate/Utility Hazard?	N/A
			Obstruction Type			Storm Grate/Utility Type	
					N/A		N/A
					Yes	Surface Condition? (G/P)	Good
Total Cost:		\$	1850.00
