Intersection ID: 48459	Main Street: TARPWAY_RD	Cross Street: QUINN_DR	Location:	N
ADA ID: 6AC9FC24C119	Ramp Type: Perp	Initial Pass/Fail: Fail	Overall Compliance: No	Severity Score: 10

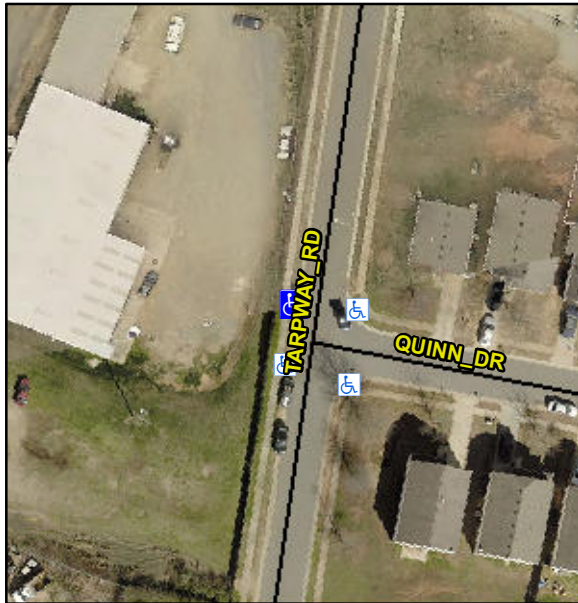
Not Found, R304.5.1

Possible Solutions:			Compliance	Description	Data	Compliance	Description	Data
Remove & Replace Entire Ramp.			N/A	Ramp Length (in)	49.0	Yes	Ramp Slope (%)	7.2
			No	Ramp Width (in)	47.0	Yes	Ramp XSlope (%)	2.6
			N/A	Flare Type LT	N/A	N/A	Flare Type RT	N/A
			N/A	Flare Slope LT (%)	N/A	N/A	Flare Slope RT (%)	N/A
			N/A	Flare Traversable LT?	N/A	N/A	Flare Traversable RT?	N/A
			N/A	Landing Length (in)	N/A	N/A	DWS Provided?	N/A
			N/A	Landing Width (in)	N/A	N/A	DWS Contrast?	N/A
			N/A	Landing Slope (%)	N/A	N/A	DWS Length (in)	N/A
			N/A	Landing X Slope (%)	N/A	N/A	DWS Full Width?	N/A
			N/A	Landing Curb? (Y/N)	N/A	N/A	DWS Offset (in)	N/A
			N/A	Shared Landing?	N/A			
			N/A	Gutter Ponding?	N/A	N/A	Gutter Slope (%)	N/A
			N/A	Gutter Lip Ht (in)	N/A	N/A	Gutter X Slope (%)	N/A
			N/A	Painted X Walk1?	No	N/A	Painted X Walk2?	N/A
				X Walk 1 Direction	To SE		X Walk 2 Direction	N/A
N/A	X Walk 1 Width (in)	N/A	N/A	X Walk 2 Width (in)	N/A

X Walk 1 Slope (%)	2.0		X Walk 2 Slope (%)	N/A			
	X Walk 1 X Slope (%)	3.1		X Walk 2 X Slope (%)	N/A			
N/A	Ramp inside XWalk1?	N/A	N/A	Ramp inside XWalk2?	N/A			
	Road Slope (%)	N/A	N/A	Clear Space?	N/A			
	Road X Slope (%)	N/A	N/A	Clear Space to XWalk (in)	N/A			
N/A	Any Obstructions?	N/A	N/A	Storm Grate/Utility Hazard?	N/A			
Total Cost:	\$	1850.00		Obstruction Type		Storm Grate/Utility Type		
					N/A			N/A
						Yes	Surface Condition? (G/P)	Good

Remove & Replace Entire Ramp.
