Access Compliance Report

Public Rights-of-Way

(Curb Ramps)

Intersection ID: 8329	Main Street: BEATTIES_FORD_RD	Cross Street: LASALLE_ST	Location:	E
ADA ID: 6AE81E125E5A	Ramp Type: Perp	Initial Pass/Fail: Fail	Overall Compliance: No	Severity Score: 21.25

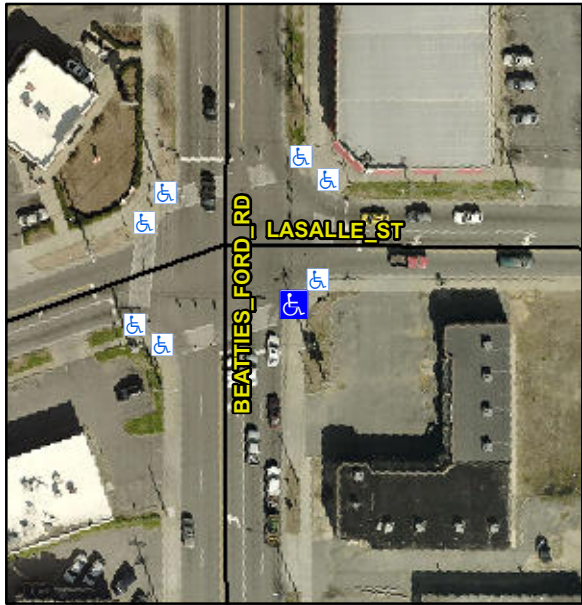
Possible Solutions:		Compliance	Description	Data	Compliance	Description	Data
	Remove & Replace Entire Ramp.		N/A	Ramp Length (in)	107.0	No	Ramp Slope (%)	8.6
			No	Ramp Width (in)	43.5	Yes	Ramp XSlope (%)	1.0
			N/A	Flare Type LT	N/A	N/A	Flare Type RT	N/A
			N/A	Flare Slope LT (%)	N/A	N/A	Flare Slope RT (%)	N/A
			N/A	Flare Traversable LT?	N/A	N/A	Flare Traversable RT?	N/A
			N/A	Landing Length (in)	N/A	N/A	DWS Provided?	N/A
			N/A	Landing Width (in)	N/A	N/A	DWS Contrast?	N/A
			N/A	Landing Slope (%)	N/A	N/A	DWS Length (in)	N/A
			N/A	Landing X Slope (%)	N/A	N/A	DWS Full Width?	N/A
Surveyor Notes:			N/A	Landing Curb? (Y/N)	N/A	N/A	DWS Offset (in)	N/A
N/A			N/A	Shared Landing?	N/A			
PROW/ADA:			N/A	Gutter Ponding?	N/A	N/A	Gutter Slope (%)	N/A
Not Found, R304.5.1, R304.2.2			N/A	Gutter Lip Ht (in)	N/A	N/A	Gutter X Slope (%)	N/A

N/A	Painted X Walk1?	Yes	N/A	Painted X Walk2?	N/A
				X Walk 1 Direction	To SW		X Walk 2 Direction	N/A
			N/A	X Walk 1 Width (in)	121.0	N/A	X Walk 2 Width (in)	N/A
				X Walk 1 Slope (%)	2.3		X Walk 2 Slope (%)	N/A
				X Walk 1 X Slope (%)	1.5		X Walk 2 X Slope (%)	N/A
			N/A	Ramp inside XWalk1?	Yes	N/A	Ramp inside XWalk2?	N/A
				Road Slope (%)	N/A	N/A	Clear Space?	N/A
				Road X Slope (%)	N/A	N/A	Clear Space to XWalk (in)	N/A
			N/A	Any Obstructions?	N/A	N/A	Storm Grate/Utility Hazard?	N/A
				Obstruction Type			Storm Grate/Utility Type	
						N/A		N/A
						Yes	Surface Condition? (G/P)	Good
