Access Compliance Report Public Rights-of-Way (Curb Ramps)

Main Street: N DAVIDSON ST Location: Intersection ID: 10608 **Cross Street: JORDAN PL** SW Initial Pass/Fail: Fail **Overall Compliance: No** 10 ADA ID: 6AFBE81923CD Ramp Type: Combination1 **Severity Score:**

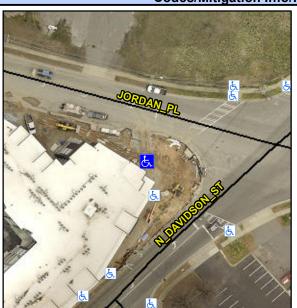
Possible Solutions: Compliance Description N/A Remove & Replace Entire Ramp. Yes Yes No N/A No Surveyor Notes: N/A LT RP < 5% N/A N/A N/A N/A PROW/ADA: N/A Not Found, R304.5.1, R304.5.3 N/A N/A N/A N/A N/A
