# Access Compliance Report

## Public Rights-of-Way

### (Curb Ramps)

| Intersection ID: 3180 | Main Street: JOHNSTON_OEHLER_RD | Cross Street: SONG_SPARROW_LN | Location: | W |

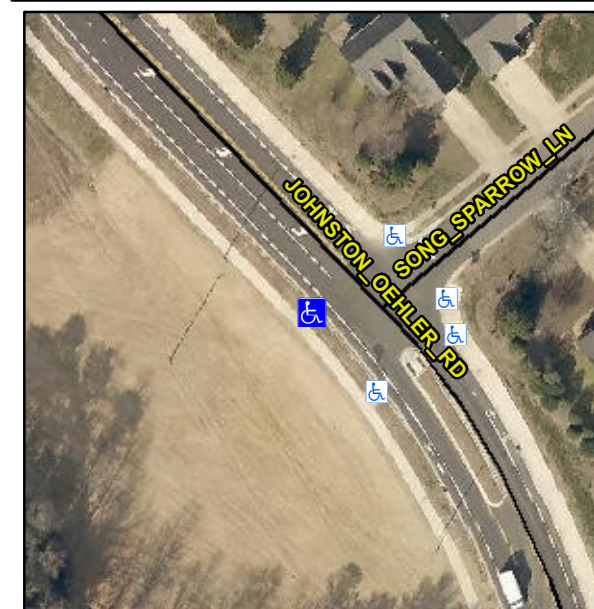
| ADA ID: 6B19C53B3319 | Ramp Type: Perp | Initial Pass/Fail: Fail | Overall Compliance: No | Severity Score: 25 |

**R304.2.2**

| Compliance | Description | Data | Compliance | Description | Data |
|---|---|---|---|---|---|
| N/A | Ramp Length (in) | 96.0 | No | Ramp Slope (%) | 13.0 |

**Remove & Replace Entire Ramp.**

**\$ 1850.00**
