Intersection ID: 44264	Main Street: ISAAC_HUNTER_DR	Cross Street: LAWING_SCHOOL_RD	Location:	N
ADA ID: 6B19CD022C97	Ramp Type: Perp	Initial Pass/Fail: Fail	Overall Compliance: No	Severity Score: 21.25

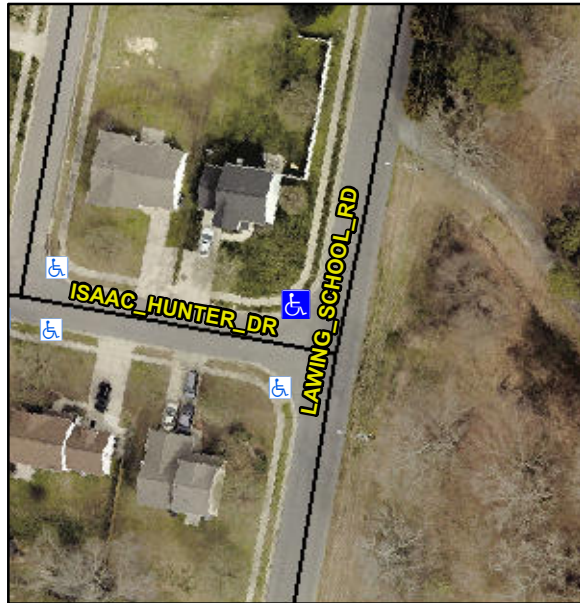
Not Found, R304.5.1, R304.2.2

Compliance	Description	Data	Compliance	Description	Data
N/A	Ramp Length (in)	43.0	No	Ramp Slope (%)	11.9
No	Ramp Width (in)	38.0	Yes	Ramp XSlope (%)	0.4
N/A	Flare Type LT	N/A	N/A	Flare Type RT	N/A
N/A	Flare Slope LT (%)	N/A	N/A	Flare Slope RT (%)	N/A
N/A	Flare Traversable LT?	N/A	N/A	Flare Traversable RT?	N/A
N/A	Landing Length (in)	N/A	N/A	DWS Provided?	N/A
N/A	Landing Width (in)	N/A	N/A	DWS Contrast?	N/A
N/A	Landing Slope (%)	N/A	N/A	DWS Length (in)	N/A
N/A	Landing X Slope (%)	N/A	N/A	DWS Full Width?	N/A
N/A	Landing Curb? (Y/N)	N/A	N/A	DWS Offset (in)	N/A
N/A	Shared Landing?	N/A			
N/A	Gutter Ponding?	N/A	N/A	Gutter Slope (%)	N/A
N/A	Gutter Lip Ht (in)	N/A	N/A	Gutter X Slope (%)	N/A
N/A	Painted X Walk1?	No	N/A	Painted X Walk2?	N/A
	X Walk 1 Direction	To SW		X Walk 2 Direction	N/A
N/A	X Walk 1 Width (in)	N/A	N/A	X Walk 2 Width (in)	N/A
	X Walk 1 Slope (%)	2.4		X Walk 2 Slope (%)	N/A
	X Walk 1 X Slope (%)	2.5		X Walk 2 X Slope (%)	N/A

N/A	Ramp inside XWalk1?	N/A	N/A	Ramp inside XWalk2?	N/A
	Road Slope (%)	N/A	N/A	Clear Space?	N/A
	Road X Slope (%)	N/A	N/A	Clear Space to XWalk (in)	N/A
N/A	Any Obstructions?	N/A	N/A	Storm Grate/Utility Hazard?	N/A
	Obstruction Type			Storm Grate/Utility Type	
		N/A			N/A
			Yes	Surface Condition? (G/P)	Good

Remove & Replace Entire Ramp.

Total Cost: \$ 1850.00

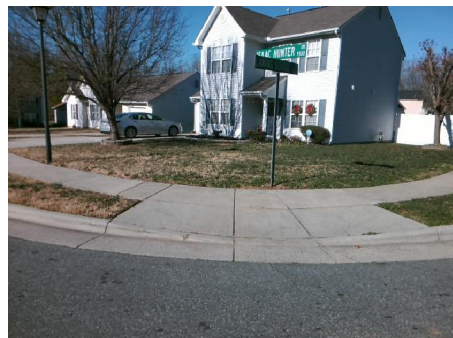
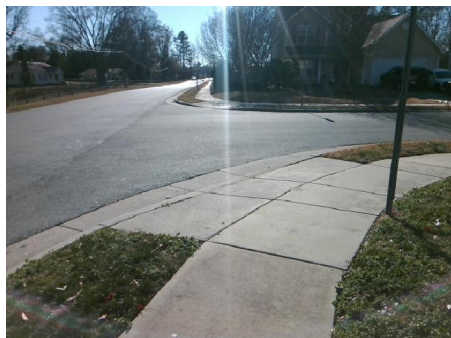
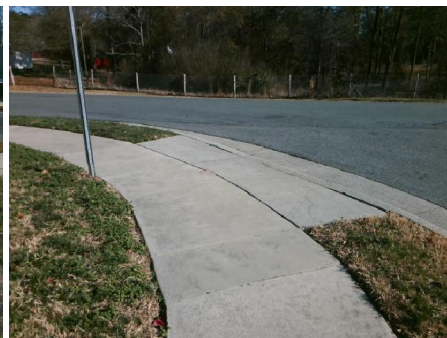
Street 1 Name	ISAAC HUNTER DR
Stop Condition-Street 2	StopSign
Street 2 Name	N/A
Stop Condition-Street 1	N/A
