# Access Compliance Report

## Public Rights-of-Way

### (Curb Ramps)

Intersection ID: 5175	Main Street: FROSTMOOR_PL	Cross Street: HAYBRIDGE_RD	Location: SE
ADA ID: 6B1DB75DBCB2	Ramp Type: Perp	Initial Pass/Fail: Fail	Overall Compliance: No
Severity Score: 46.25			
Codes/Mitigation Info/Possible Solution		Field Measurements/Component Compliance

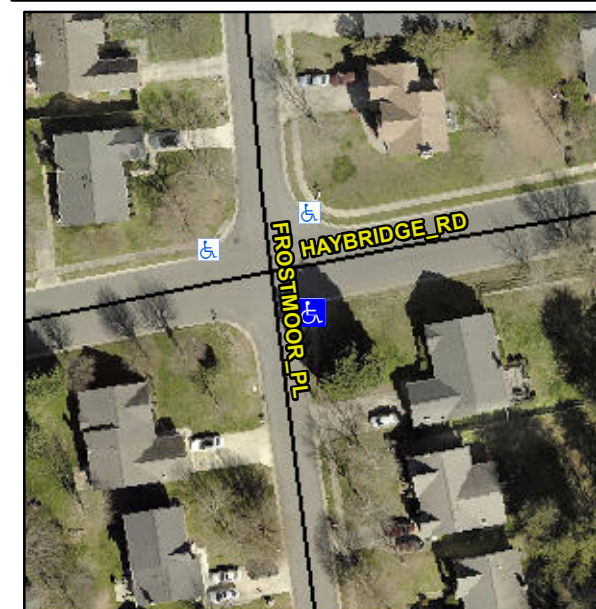
Compliance	Description	Data	Compliance	Description	Data
N/A	Ramp Length (in)	51.0	No	Ramp Slope (%)	9.2
No	Ramp Width (in)	47.0	No	Ramp XSlope (%)	8.5
N/A	Flare Type LT	N/A	N/A	Flare Type RT	N/A
N/A	Flare Slope LT (%)	N/A	N/A	Flare Slope RT (%)	N/A
N/A	Flare Traversable LT?	N/A	N/A	Flare Traversable RT?	N/A
N/A	Landing Length (in)	N/A	N/A	DWS Provided?	N/A
N/A	Landing Width (in)	N/A	N/A	DWS Contrast?	N/A
N/A	Landing Slope (%)	N/A	N/A	DWS Length (in)	N/A
N/A	Landing X Slope (%)	N/A	N/A	DWS Full Width?	N/A
N/A	Landing Curb? (Y/N)	N/A	N/A	DWS Offset (in)	N/A
N/A	Shared Landing?	N/A			
N/A	Gutter Ponding?	N/A	N/A	Gutter Slope (%)	N/A
N/A	Gutter Lip Ht (in)	N/A	N/A	Gutter X Slope (%)	N/A
N/A	Painted X Walk1?	No	N/A	Painted X Walk2?	N/A
	X Walk 1 Direction	To N		X Walk 2 Direction	N/A
N/A	X Walk 1 Width (in)	N/A	N/A	X Walk 2 Width (in)	N/A
	X Walk 1 Slope (%)	1.2		X Walk 2 Slope (%)	N/A
	X Walk 1 X Slope (%)	5.8		X Walk 2 X Slope (%)	N/A

N/A	Ramp inside XWalk1?	N/A	N/A	Ramp inside XWalk2?	N/A
	Road Slope (%)	N/A	N/A	Clear Space?	N/A
	Road X Slope (%)	N/A	N/A	Clear Space to XWalk (in)	N/A
N/A	Any Obstructions?	N/A	N/A	Storm Grate/Utility Hazard?	N/A
	Obstruction Type			Storm Grate/Utility Type	
		N/A			N/A
			Yes	Surface Condition? (G/P)	Good

**Remove & Replace Entire Ramp.**
