Access Compliance Report Public Rights-of-Way (Curb Ramps)

Intersection ID: 10000 Main Street: FONTANA_AV **Cross Street: WHISNANT_ST** Location: N **Overall Compliance: No** ADA ID: 6B202228C14E Ramp Type: Perp Initial Pass/Fail: Fail **Severity Score:** 8.75

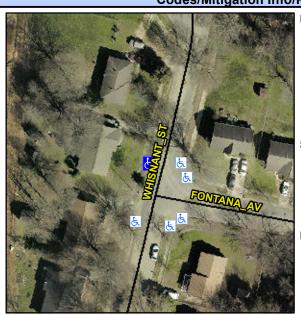
Field Measurements/Component Compliance								
Compl	iance Description	Data	Compli	ance	Description	Data		
N/A	Ramp Length (in)	53.0	Yes	Ramp	Slope (%)	8.2		
No	Ramp Width (in)	43.0	Yes Ramp XSlope (%)		XSlope (%)	1.9		
N/A	Flare Type LT	N/A	N/A Flare Type RT		Type RT	N/A		
N/A	Flare Slope LT (%)	N/A	N/A Flare Slope RT (%)		Slope RT (%)	N/A		
N/A	Flare Traversable LT?	N/A	N/A Flare Traversable RT?		Traversable RT?	N/A		
N/A	Landing Length (in)	N/A	N/A	DWS	Provided?	N/A		
N/A	Landing Width (in)	N/A	N/A	DWS	Contrast?	N/A		
N/A	Landing Slope (%)	N/A	N/A	DWS	Length (in)	N/A		
N/A	Landing X Slope (%)	N/A	N/A	DWS	Full Width?	N/A		
N/A	Landing Curb? (Y/N)	N/A	N/A	DWS	Offset (in)	N/A		
N/A	Shared Landing?	N/A						
N/A	Gutter Ponding?	N/A	N/A	Gutte	r Slope (%)	N/A		
N/A	Gutter Lip Ht (in)	N/A	N/A	Gutte	r X Slope (%)	N/A		
N/A	Painted X Walk1?	No	N/A	Paint	ed X Walk2?	N/A		
	X Walk 1 Direction	То Е		X Wa	lk 2 Direction	N/A

N/A	X Walk 1 Width (in)	N/A	N/A	X Wa	lk 2 Width (in)	N/A		
	X Walk 1 Slope (%)	3.0		X Wa	lk 2 Slope (%)	N/A		
	X Walk 1 X Slope (%)	1.7		X Wa	lk 2 X Slope (%)	N/A		
N/A	Ramp inside XWalk1?	N/A	N/A	Ramp	inside XWalk2?	N/A		
	Road Slope (%)	N/A	N/A	Clear	Space?	N/A		
	Road X Slope (%)	N/A	N/A	Clear	Space to XWalk (in)	N/A		
N/A	Any Obstructions?	N/A	N/A	Storm	n Grate/Utility Hazard?	N/A		
	Obstruction Type			Storm	n Grate/Utility Type			
		N/A				N/A		
			Yes	Surfa	ce Condition? (G/P)	Good

Possible Solutions:	<u>c</u>	
Remove & Replace Entire Ramp.		
	N	
	N	
	N	
	N	
	N	
Surveyor Notes:	N	
N/A	N	
	N	
	N	
	N	
PROW/ADA:	N	
Not Found, R304.5.1	N	
	N	
	N	
	N
