# Access Compliance Report

## Public Rights-of-Way

### (Curb Ramps)

Intersection ID: 42367	Main Street: FALCONCREST_DR	Cross Street: KESTRAL_RIDGE_DR	Location: S
ADA ID: 6B307B7EC652	Ramp Type: PerpDiag	Initial Pass/Fail: Pass	Overall Compliance: No
Severity Score: 20			
Codes/Mitigation Info/Possible Solution		Field Measurements/Component Compliance

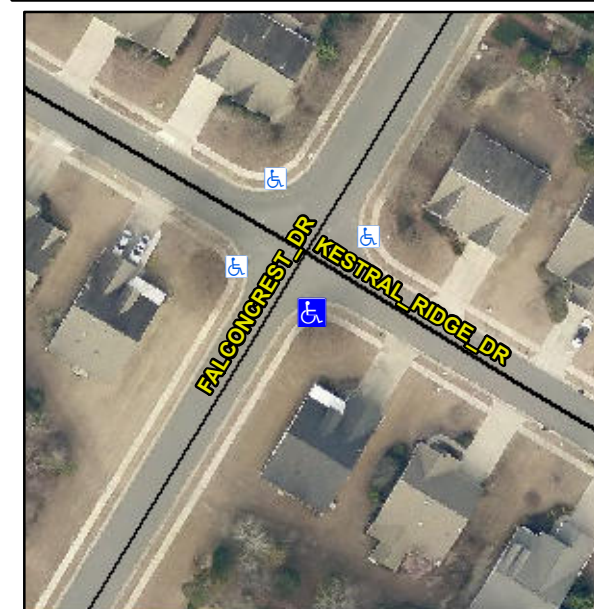
**Not Found, R304.2.2, R304.2.1, R304.2.2-Perp, R304.3.2-Para, R305, R302.7.2**

Compliance	Description	Data	Compliance	Description	Data
N/A	Ramp Length (in)	48.0	No	Ramp Slope (%)	8.5
Yes	Ramp Width (in)	50.0	Yes	Ramp XSlope (%)	0.1
N/A	Flare Type LT	Sloped	N/A	Flare Type RT	N/A
N/A	Flare Slope LT (%)	2.4	N/A	Flare Slope RT (%)	3.0
N/A	Flare Traversable LT?	No	N/A	Flare Traversable RT?	No
No	Landing Length (in)	47.0	No	DWS Provided?	No
Yes	Landing Width (in)	52.0	N/A	DWS Contrast?	No
No	Landing Slope (%)	2.6	N/A	DWS Length (in)	N/A
Yes	Landing X Slope (%)	0.5	N/A	DWS Full Width?	No
N/A	Landing Curb? (Y/N)	No	N/A	DWS Offset (in)	N/A
N/A	Shared Landing?	No			
Yes	Gutter Ponding?	No	Yes	Gutter Slope (%)	0.2
No	Gutter Lip Ht (in)	0.5	Yes	Gutter X Slope (%)	0.0
N/A	Painted X Walk1?	No	N/A	Painted X Walk2?	No
	X Walk 1 Direction	To NE		X Walk 2 Direction	To NW
N/A	X Walk 1 Width (in)	N/A	N/A	X Walk 2 Width (in)	N/A
	X Walk 1 Slope (%)	1.6		X Walk 2 Slope (%)	3.4
	X Walk 1 X Slope (%)	1.7		X Walk 2 X Slope (%)	1.3

N/A	Ramp inside XWalk1?	N/A	N/A	Ramp inside XWalk2?	N/A
	Road Slope (%)	0.2	N/A	Clear Space?	Yes
	Road X Slope (%)	3.4	N/A	Clear Space to XWalk (in)	N/A
Yes	Any Obstructions?	No	Yes	Storm Grate/Utility Hazard?	No
	Obstruction Type			Storm Grate/Utility Type	
		N/A			N/A
			Yes	Surface Condition? (G/P)	Good

**Remove & Replace Curb Ramp With Two New Directional Ramps or Equivalent.**
