# Access Compliance Report

## Public Rights-of-Way

### (Curb Ramps)

Intersection ID: 44110	Main Street: GLENLUCE_AV	Cross Street: STAFFORDSHIRE_LN	Location: N
ADA ID: 6B31965CA069	Ramp Type: PerpDiag	Initial Pass/Fail: Fail	Overall Compliance: No
Severity Score: 33.75			
Codes/Mitigation Info/Possible Solution		Field Measurements/Component Compliance

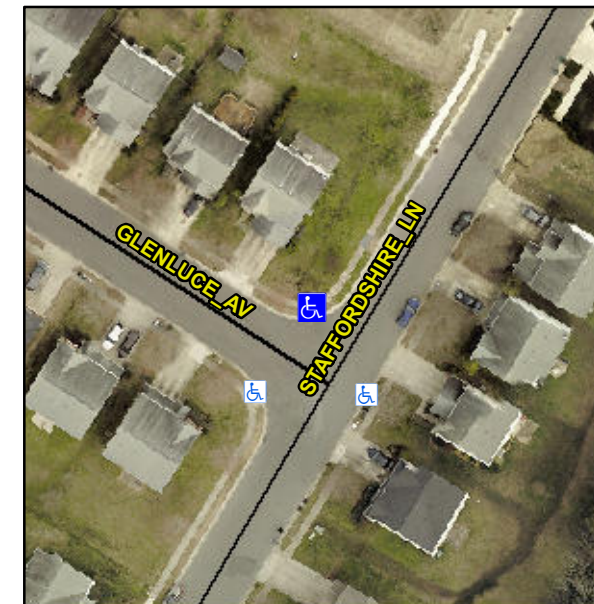
**Not Found, R304.5.1, R304.5.3**

Compliance	Description	Data	Compliance	Description	Data
N/A	Ramp Length (in)	48.0	Yes	Ramp Slope (%)	5.6
No	Ramp Width (in)	47.0	No	Ramp XSlope (%)	12.2
N/A	Flare Type LT	N/A	N/A	Flare Type RT	N/A
N/A	Flare Slope LT (%)	N/A	N/A	Flare Slope RT (%)	N/A
N/A	Flare Traversable LT?	N/A	N/A	Flare Traversable RT?	N/A
N/A	Landing Length (in)	N/A	N/A	DWS Provided?	N/A
N/A	Landing Width (in)	N/A	N/A	DWS Contrast?	N/A
N/A	Landing Slope (%)	N/A	N/A	DWS Length (in)	N/A
N/A	Landing X Slope (%)	N/A	N/A	DWS Full Width?	N/A
N/A	Landing Curb? (Y/N)	N/A	N/A	DWS Offset (in)	N/A
N/A	Shared Landing?	N/A			
N/A	Gutter Ponding?	N/A	N/A	Gutter Slope (%)	N/A
N/A	Gutter Lip Ht (in)	N/A	N/A	Gutter X Slope (%)	N/A
N/A	Painted X Walk1?	No	N/A	Painted X Walk2?	No
	X Walk 1 Direction	To SW		X Walk 2 Direction	To SE
N/A	X Walk 1 Width (in)	N/A	N/A	X Walk 2 Width (in)	N/A
	X Walk 1 Slope (%)	0.2		X Walk 2 Slope (%)	9.1
	X Walk 1 X Slope (%)	10.2		X Walk 2 X Slope (%)	3.8

N/A	Ramp inside XWalk1?	N/A	N/A	Ramp inside XWalk2?	N/A
	Road Slope (%)	8.7	N/A	Clear Space?	N/A
	Road X Slope (%)	3.3	N/A	Clear Space to XWalk (in)	N/A
N/A	Any Obstructions?	N/A	N/A	Storm Grate/Utility Hazard?	N/A
	Obstruction Type			Storm Grate/Utility Type	
		N/A			N/A
			Yes	Surface Condition? (G/P)	Good

**Remove & Replace Curb Ramp With Two New Directional Ramps or Equivalent.**

Total Cost: \$ 3200.00
