Access Compliance Report

Public Rights-of-Way

(Curb Ramps)

Intersection ID: 10037285	Main Street: SARDIS_RD_NORTH	Cross Street: N/A	Location: NE
ADA ID: 6B447F9664D5	Ramp Type: Para	Initial Pass/Fail: Fail	Overall Compliance: No
Codes/Mitigation Info/Possible Solution		Field Measurements/Component Compliance	
Severity Score: 13.75

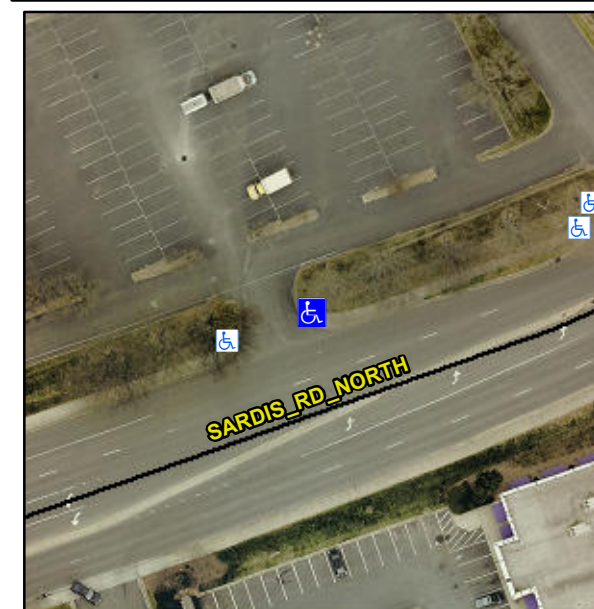
Surveyor Notes:

LT RP < 5%

PROW/ADA:

R304.5.3, R304.3.2

Compliance	Description	Data	Compliance	Description	Data
N/A	Ramp Length LT (in)	48.0	N/A	Ramp Length RT (in)	52.0
Yes	Ramp Width LT (in)	70.0	Yes	Ramp Width RT (in)	72.0
Yes	Ramp Slope LT (%)	3.5	No	Ramp Slope RT (%)	11.1
No	Ramp XSlope LT (%)	3.2	No	Ramp XSlope RT (%)	2.1
N/A	Landing Length (in)	N/A	N/A	DWS Provided?	N/A
N/A	Landing Width (in)	N/A	N/A	DWS Contrast?	N/A
N/A	Landing Slope (%)	N/A	N/A	DWS Length (in)	N/A
N/A	Landing X Slope (%)	N/A	N/A	DWS Full Width?	N/A
N/A	Landing Curb? (Y/N)	N/A	N/A	DWS Offset (in)	N/A
N/A	Shared Landing?	N/A			
N/A	Gutter Ponding?	N/A	N/A	Gutter Slope (%)	N/A
N/A	Gutter Lip Ht (in)	N/A	N/A	Gutter X Slope (%)	N/A
N/A	Painted X Walk1?	No	N/A	Painted X Walk2?	N/A
	X Walk 1 Direction	To SW		X Walk 2 Direction	N/A
N/A	X Walk 1 Width (in)	N/A	N/A	X Walk 2 Width (in)	N/A
	X Walk 1 Slope (%)	0.5		X Walk 2 Slope (%)	N/A
	X Walk 1 X Slope (%)	2.4		X Walk 2 X Slope (%)	N/A
N/A	Ramp inside XWalk1?	N/A	N/A	Ramp inside XWalk2?	N/A

Road Slope (%)	N/A	N/A	Clear Space?	N/A
	Road X Slope (%)	N/A	N/A	Clear Space to XWalk (in)	N/A
N/A	Any Obstructions?	N/A	N/A	Storm Grate/Utility Hazard?	N/A
	Obstruction Type			Storm Grate/Utility Type	
		N/A			N/A
			Yes	Surface Condition? (G/P)	Good
			N/A	Curb Slope (%)	3.6

Possible Solutions:

Remove & Replace Entire Ramp.

Total Cost: \$ 1600.00
