## **Access Compliance Report Public Rights-of-Way** (Curb Ramps)

Intersection ID: 10662 Main Street: E 36TH ST **Cross Street: HOLT ST** Location:

**Overall Compliance: No** ADA ID: 6B47C7790EF2 Ramp Type: PerpDiag Initial Pass/Fail: Fail Severity Score: 13.75

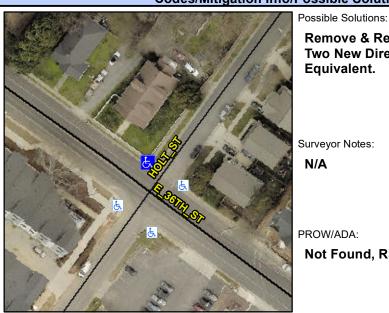
ot Found, R304.2.2, R304.5.3

Comp	Compliance Description		Compliance Description		Data
N/A	Ramp Length (in)	48.0	No	Ramp Slope (%)	8.5
Yes	Ramp Width (in)	48.0	No	Ramp XSlope (%)	3.2
N/A	Flare Type LT	N/A	N/A	Flare Type RT	N/A
N/A	Flare Slope LT (%)	N/A	N/A	Flare Slope RT (%)	N/A
N/A	Flare Traversable LT?	N/A	N/A	Flare Traversable RT?	N/A
N/A	Landing Length (in)	N/A	N/A	DWS Provided?	N/A
N/A	Landing Width (in)	N/A	N/A	DWS Contrast?	N/A
N/A	Landing Slope (%)	N/A	N/A	DWS Length (in)	N/A
N/A	Landing X Slope (%)	N/A	N/A	DWS Full Width?	N/A
N/A	Landing Curb? (Y/N)	N/A	N/A	DWS Offset (in)	N/A
N/A	Shared Landing?	N/A			
N/A	Gutter Ponding?	N/A	N/A	Gutter Slope (%)	N/A
N/A	Gutter Lip Ht (in)	1.0	N/A	Gutter X Slope (%)	N/A
N/A	Painted X Walk1?	No	N/A	Painted X Walk2?	No
	X Walk 1 Direction	To SW		X Walk 2 Direction	To SE
N/A	X Walk 1 Width (in)	N/A	N/A	X Walk 2 Width (in)	N/A
	X Walk 1 Slope (%)	3.2		X Walk 2 Slope (%)	2.9
	X Walk 1 X Slope (%)	2.3		X Walk 2 X Slope (%)	0.2

N/A	Ramp inside XWalk1?	N/A	N/A	Ramp inside XWalk2?	N/A
	Road Slope (%)	0.8	N/A	Clear Space?	N/A
	Road X Slope (%)	7.5	N/A	Clear Space to XWalk (in)	N/A
N/A	Any Obstructions?	N/A	N/A	Storm Grate/Utility Hazard?	N/A
	Obstruction Type		l	Storm Grate/Utility Type	
		N/A			N/A

Street 1 Name Stop Condition-Street 2 Street 2 Name Stop Condition-Street 1 Remove & Replace Curb Ramp With **Two New Directional Ramps or** Equivalent.

Total Cost: 3200.00
