Intersection ID: 10031994	Main Street: MONROE_RD	Cross Street: N/A	Location:	NE
ADA ID: 6B52D85F3DF3	Ramp Type: ParaDiag	Initial Pass/Fail: Fail	Overall Compliance: No	Severity Score: 13.75

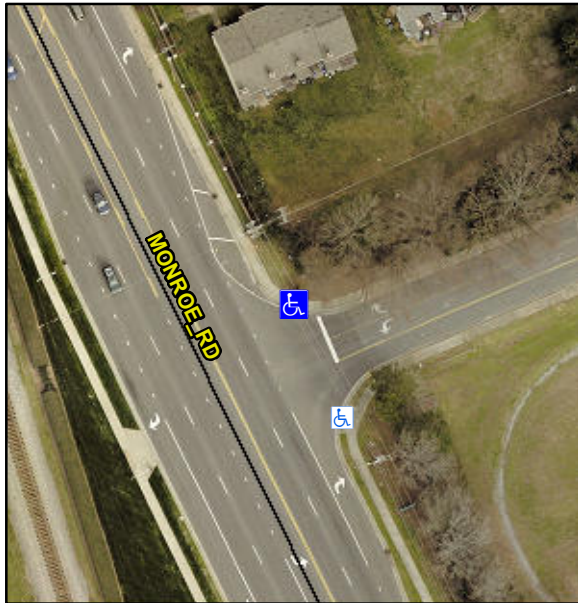
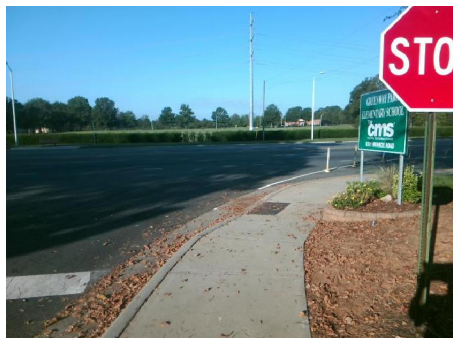
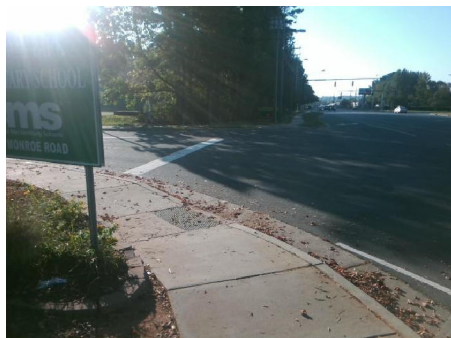
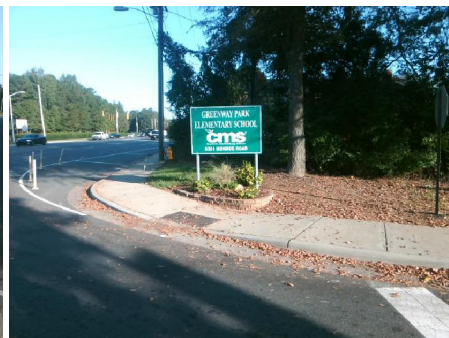
**RT RP < 5%**

**R304.3.2, R304.5.3**

Compliance	Description	Data	Compliance	Description	Data
N/A	Ramp Length LT (in)	59.0	N/A	Ramp Length RT (in)	69.0
Yes	Ramp Width LT (in)	59.0	Yes	Ramp Width RT (in)	59.0
No	Ramp Slope LT (%)	9.7	Yes	Ramp Slope RT (%)	4.7
No	Ramp XSlope LT (%)	4.4	No	Ramp XSlope RT (%)	2.8
N/A	Landing Length (in)	N/A	N/A	DWS Provided?	N/A
N/A	Landing Width (in)	N/A	N/A	DWS Contrast?	N/A
N/A	Landing Slope (%)	N/A	N/A	DWS Length (in)	N/A
N/A	Landing X Slope (%)	N/A	N/A	DWS Full Width?	N/A
N/A	Landing Curb? (Y/N)	N/A	N/A	DWS Offset (in)	N/A
N/A	Shared Landing?	N/A			
N/A	Gutter Ponding?	N/A	N/A	Gutter Slope (%)	N/A
N/A	Gutter Lip Ht (in)	N/A	N/A	Gutter X Slope (%)	N/A
N/A	Painted X Walk1?	No	N/A	Painted X Walk2?	No
	X Walk 1 Direction	To W		X Walk 2 Direction	To S
N/A	X Walk 1 Width (in)	N/A	N/A	X Walk 2 Width (in)	N/A
	X Walk 1 Slope (%)	2.3		X Walk 2 Slope (%)	1.3
	X Walk 1 X Slope (%)	0.7		X Walk 2 X Slope (%)	1.4
N/A	Ramp inside XWalk1?	N/A	N/A	Ramp inside XWalk2?	N/A

Road Slope (%)	2.1	N/A	Clear Space?	N/A
	Road X Slope (%)	2.8	N/A	Clear Space to XWalk (in)	N/A
N/A	Any Obstructions?	N/A	N/A	Storm Grate/Utility Hazard?	N/A
	Obstruction Type			Storm Grate/Utility Type	
		N/A			N/A
			Yes	Surface Condition? (G/P)	Good
			N/A	Curb Slope (%)	7.5

**Remove & Replace Curb Ramp With Two New Directional Ramps or Equivalent.**

**Total Cost: \$ 3200.00**
