Access Compliance Report

Public Rights-of-Way (Curb Ramps)

Intersection ID: 51011	Main Street: TREMONT_PLACE_RD	Cross Street: BENDING_BRANCH_RD	Location:	S
ADA ID: 6B63AB3C6D76	Ramp Type: Perp	Initial Pass/Fail: Fail	Overall Compliance: No	Severity Score: 22.5
Codes/Mitigation Info/Possible Solution		Field Measurements/Component Compliance

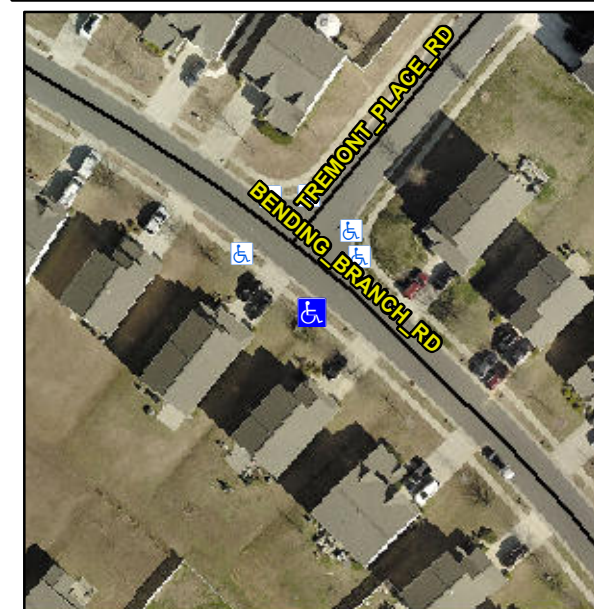
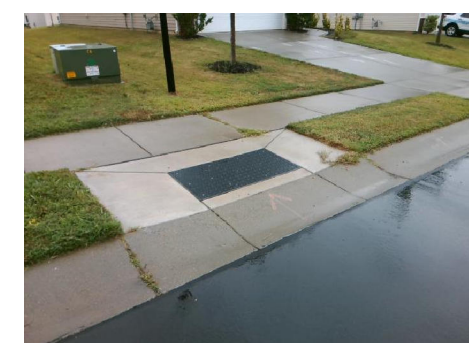
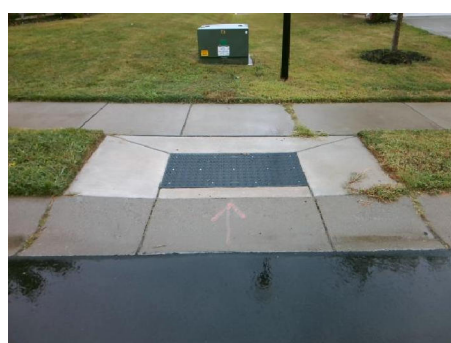
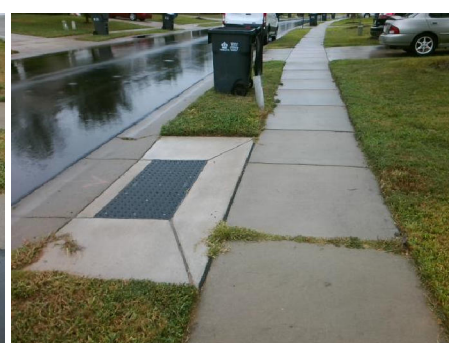
Not Found, R304.5.1, R304.2.2

Compliance	Description	Data	Compliance	Description	Data
N/A	Ramp Length (in)	46.5	No	Ramp Slope (%)	8.4
No	Ramp Width (in)	47.0	Yes	Ramp XSlope (%)	2.9
N/A	Flare Type LT	N/A	N/A	Flare Type RT	N/A
N/A	Flare Slope LT (%)	N/A	N/A	Flare Slope RT (%)	N/A
N/A	Flare Traversable LT?	N/A	N/A	Flare Traversable RT?	N/A
N/A	Landing Length (in)	N/A	N/A	DWS Provided?	N/A
N/A	Landing Width (in)	N/A	N/A	DWS Contrast?	N/A
N/A	Landing Slope (%)	N/A	N/A	DWS Length (in)	N/A
N/A	Landing X Slope (%)	N/A	N/A	DWS Full Width?	N/A
N/A	Landing Curb? (Y/N)	N/A	N/A	DWS Offset (in)	N/A
N/A	Shared Landing?	N/A			
N/A	Gutter Ponding?	N/A	N/A	Gutter Slope (%)	N/A
N/A	Gutter Lip Ht (in)	N/A	N/A	Gutter X Slope (%)	N/A
N/A	Painted X Walk1?	No	N/A	Painted X Walk2?	N/A
	X Walk 1 Direction	To NE		X Walk 2 Direction	N/A
N/A	X Walk 1 Width (in)	N/A	N/A	X Walk 2 Width (in)	N/A
	X Walk 1 Slope (%)	1.7		X Walk 2 Slope (%)	N/A
	X Walk 1 X Slope (%)	3.1		X Walk 2 X Slope (%)	N/A

N/A	Ramp inside XWalk1?	N/A	N/A	Ramp inside XWalk2?	N/A
	Road Slope (%)	N/A	N/A	Clear Space?	N/A
	Road X Slope (%)	N/A	N/A	Clear Space to XWalk (in)	N/A
N/A	Any Obstructions?	N/A	N/A	Storm Grate/Utility Hazard?	N/A
	Obstruction Type			Storm Grate/Utility Type	
		N/A			N/A
			Yes	Surface Condition? (G/P)	Good

Possible Solutions:

Remove & Replace Entire Ramp.
